Cylinder Block Deck Cracks On Caterpillar 3208 Engines

The AERA Technical Committee and Caterpillar explain how to inspect the Caterpillar 3208 engines for block cracks.

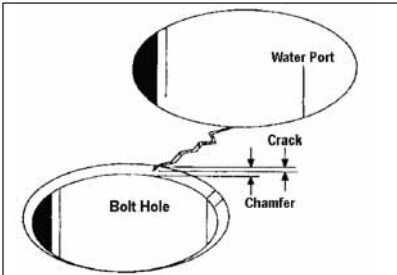
Figure 1 Cracked Cat 3208 heads can be used in service as long as the cracks don't extend below the depth of the bolt hole chamfer.

Caterpillar has approved the use of a cylinder block with cracks between the water port and the cylinder head bolt hole. However, the cracks must not extend below the depth of the bolt hole chamfer as shown in **Figure 1**, left.

A 3208 engine cylinder block that meets the inspection guidelines can be expected to perform normally in the same application until the next overhaul. Never install a cylinder block that does not meet the guidelines provided by Caterpillar.

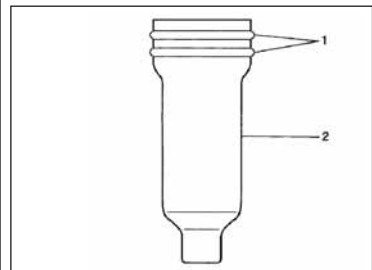
Figure 3 The 2001-2006 GM 6.6L Duramax diesel engine uses a removable sleeve to locate and house the injectors. These sleeves are in direct contact with the engine coolant, which allows the injector to be a constant temperature.

1) Lubricate the new injector O-rings (1) and place in the injector sleeve (2) grooves (see **Figure 3**, page 30).

2) Apply sealant (Loctite® 272 or equivalent) to the lower sealing area of injector sleeve.

3) Place the sleeve in its respective bore and use the sleeve remover/installer tool (p/n J45910) to install the sleeve.

4) Lightly tap on the J45910 with a hammer to install and seat the fuel injector sleeve.

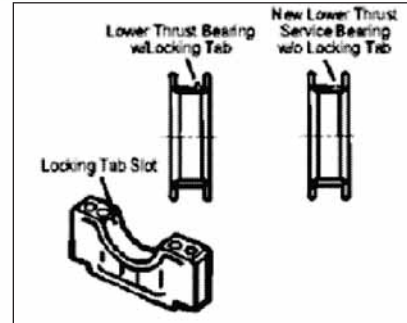
Figure 4 The 7.3L Navistar diesel uses a modified thrust main bearing in the Number 5 position. The bearing has been modified by removing the locking tab.

ranted, is the result of a revised bearing introduced with the model year 2000 engines. The new lower thrust main bearing (#5 position only) was released for production and service for ease of installation. The bearing was modified by removing the locking tab as shown in **Figure 4**, page 32.

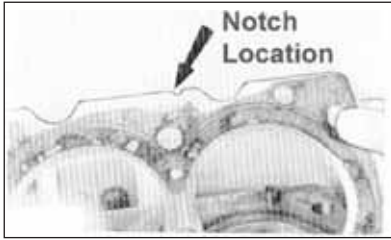
Figure 6 The proper head gasket for use on a Deutz 1011 will be identified by its notches or by the engine's piston compression height.

The cylinder head gaskets are identified by a notch(s) cut out of the gaskets outer edge as shown in **Figures 6** and **7** (above). There are three different gaskets available and the correct selection is based upon the present piston protrusion of that engine. The different notch(s) on the head gasket indicate the gaskets thickness.

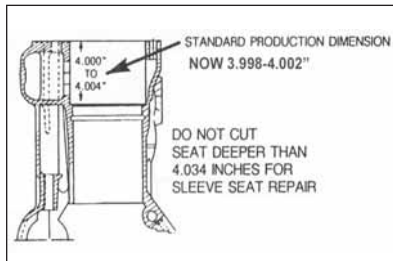
Figure 9 The original counterbore distance from the top deck of the Mack block has been modified slightly to 3.998"-4.002"

It should also be noted that the original counterbore distance from the top deck of the block has been

modified slightly to 3.998"-4.002" (see **Figure 9**, left). Don't cut the counterbore depth deeper than 4.034" (102.463 mm) when making seat repairs.

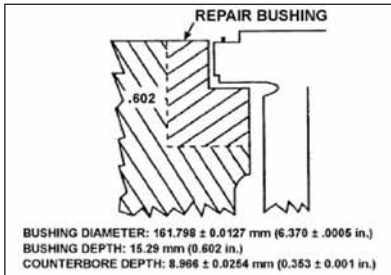
Figure 10 Repairs to the upper bore of several Detroit Diesel 60-series engines can be accomplished by pressing in a new repair bushing and using the dimensions show to the right.

This bulletin applies only to the new DDC parts (p/n 23525500), as shown in **Figure 10**, left.

DDC now offers an upper repair bushing (p/n 23525500). The repair requires boring the damaged bores and pressing the insert into the block deck. DDC also offers specific tooling

After the repair bushing has been inserted into the block, the sleeve counterbore must be machined into each installed bushing. Cut the counterbore ledge depth to .352~.354"

(8.941-8.991 mm) using the appropriate counterbore tooling.
