GENERAL MOTORS

Revised Timing Chain Design For 2000-2003 GM 2.2L VIN D & F Engines

Timing Component Positioning For 1994-2003 GM 2.2L VIN 4 Engines

Alternative Cam Bearing For 1993-2005 GM 3.1L & 3.4L VIN E, J, M & S Engines

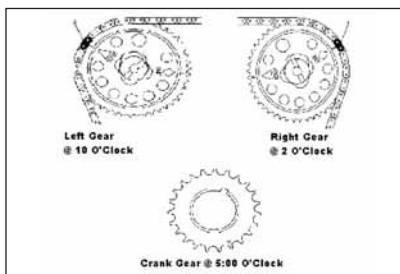
Figure 1 Revised timing chain index links for 2000-'03 2.2L GM engines are now two common links and one unique colored link.

Service manuals for the affected engines may have, in the past, explained that the timing chain index links were colored silver and copper. With the implementation of the newer design chain and oiler assembly, the index link colors have changed. In order to avoid confusion, the service procedure text has been modified and now refers to the index links as two common col-

ored links and one unique colored link (**Figure 1**, below).

This new nozzle has higher flow rate characteristics that will increase oil flow to the timing chain under low rpm operating conditions. Whenever you are replacing a timing chain, it is important to install the new oiler nozzle.

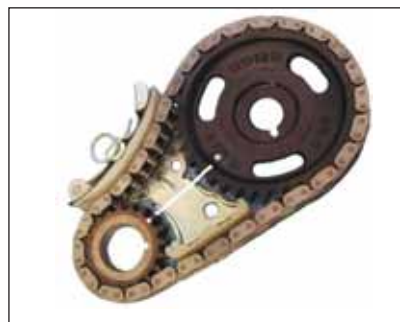
The biggest area of concern is on the cam sprocket, say builders. GM's traditional method of marking has been a raised casting area to look like a "dot," as shown in **Figure 2**, right. However, depending on the manufacturer, there may not be a familiar "dot" near the outer "tooth area." Additionally, some service manuals published in the past have been unclear about any illustration showing markings and keyway locations for both crank and cam sprockets.

The components are correctly timed when they appear as shown in **Figure 2**. There are also two tabs on the timing chain tensioner to assist in aligning the marks properly.

Figure 2 White line and dots mark correct timing for 1994-2003 GM 2.2L engines. Note cam dowel and crank keyway locations.

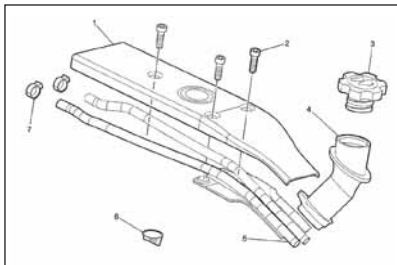
Figure 3 Crankcase ventilation (PCV) kit for 2003-'04 3.2L GM engines

been most noticeable during extremely cold weather conditions and is most prevalent on the left side just below the oil fill hole in the cam/valve cover.

This condition may be due to the closed crankcase ventilation system

becoming blocked by ice. When the ventilation system is blocked, the crankcase vapors and engine oil will then vent through the cam/valve cover seals.

To repair this type of condition, GM now offers a revised Positive Crankcase Ventilation (PCV) hose kit and oil filler cap (**Figure 3**, above left). Installing the kit and cap will keep water from accumulating and freezing in the ventilation system. The PCV kit is available as p/n 55558592, and the oil filler cap is p/n 12589430.

- 1) Enlarge two drilled holes in the primary vent hose adapter.
- 2) Shorten two existing hoses.
- 3) Install a new secondary PCV vent hose adapter
- 4) Reseal the entire system.

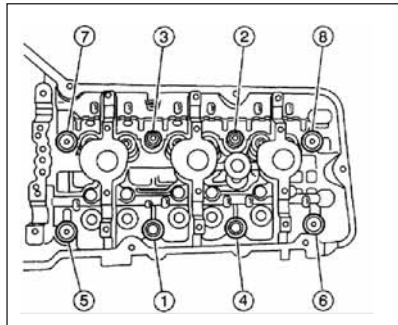
Figure 4 GM 3.5L cylinder head M11 bolt torque sequence

1) Align the cylinder head with the deck face locating pins (**Figure 4**, page 10, left side shown, right side similar).

5) Tighten the NEW M11 cylinder head bolts a first pass in sequence to 22 ft.lbs. (40 Nm).

6) Tighten the M11 cylinder head bolts a second pass in sequence an additional 60°.

7) Tighten the M11 cylinder head bolts a third pass in sequence an additional 60°.

8) Tighten the M11 cylinder head bolts a final pass in sequence an additional 80° (total step 6-8 equals 200°)

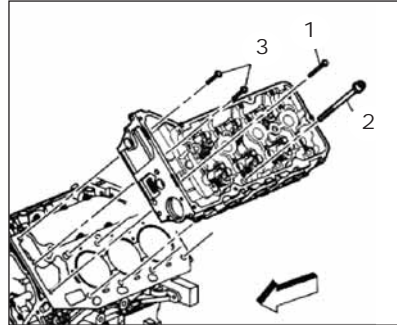
Figure 5 Cylinder head M6 (numbers 1 and 2) bolt locations on GM 3.5L

3) Install new M11 cylinder head bolts and finger tighten (number 2 in **Figure 5**, page 10).

4) Install the M6 cylinder head bolts at the front of the cylinder head. Install the longer M6 cylinder head bolt (number 1 in **Figure 5**) in the outboard location as shown. Install the two shorter M6 cylinder head bolts (number 3 in **Figure 5**) in the locations shown.

9) Tighten the long M6 cylinder head bolt (number 1 in **Figure 5**) to 106 in.lbs. (12 Nm).

10) Tighten the two shorter M6 cylinder head bolts (number 3 in **Figure 5**) to 106 in.lbs. (12 Nm).

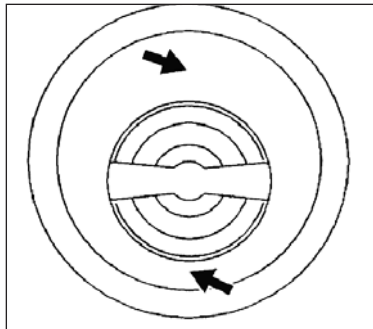
During the 1999 and 2000 model year production a design change occurred and that change affects service replacements of all previous year engines. Due to a change in the position of the pintle and a different shape of the upper thermostat assembly, the new design will not fit previous 90 degree V6 engines.

Refer to **Figure 6**, page 13, for identification of the current thermostat and the noticeable offset of the pintle position.

Figure 6 Offset thermostat pintle position on 1994-2000 3.8L GM engines.

Parts are currently available from GMSP0. Use the table shown (**Chart 2**, above) to order the correct replace-

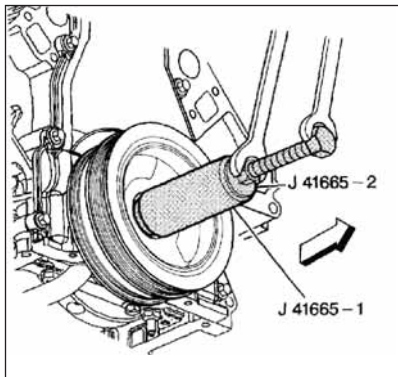
Figure 7 Installer tool J41665 will aid installation of balancer and sprocket.

3) Use a wrench and hold the hex end of the threaded rod; use a second wrench and rotate the installation tool nut clockwise until the balancer is started onto crankshaft (**Figure 7**, page 13).

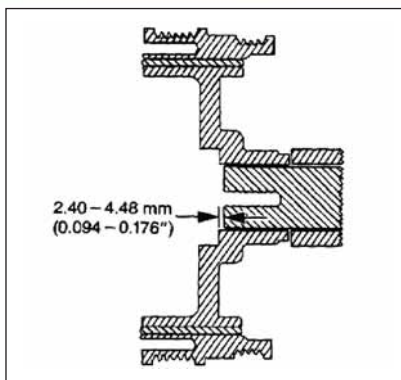
Figure 8 The nose of the crankshaft should be recessed .094"-.176"

9) Remove the used crankshaft balancer bolt. Important: The nose of the crankshaft should be recessed .094"-.176" (2.4 - 4.48 mm) into the balancer bore as shown in **Figure 8** (page 13).

10) Measure for a correctly installed balancer. If the balancer is not installed to the proper dimensions, install the J41665 and repeat the installation procedure.

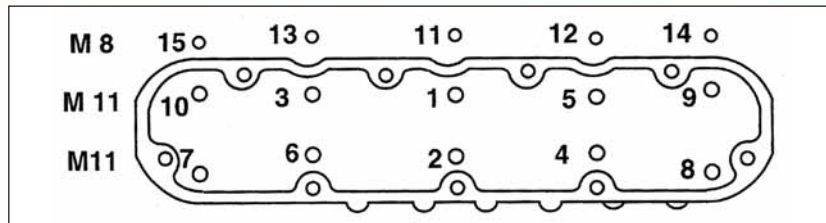
Like the caution regarding GM's Vortec engines, it has been reported that cylinder bore distortion is prevalent in these blocks. As is the case with the 5.7L, it is extremely important to use a stress plate while boring/honing for oversize pistons. The pistons used for this engine are a short skirt design and piston noise is likely if excessive clearance exists.

As much as .002" out of round has been reported when measuring bore size with and without stress plates installed. Each block (and cylinder) may vary on the exact amount of distortion as cylinder wall thickness is not identical on all blocks.

Figure 9 Torque the cylinder head bolts in the following sequence for 1999-'06 6.0L GM engines.

To measure distortion on a particular block, it is suggested to measure and record bore sizes for all eight cylinders. Then, install a new head gasket along with the heads and torque the bolts in the following sequence (see **Figure 9**, page 14, for details).

1) Tighten the 11 mm bolts (1-10) in sequence to 22 ft.lbs.

2) Rotate those bolts (1-10) in sequence an additional 90° turn using a torque angle meter.

3) Rotate only bolts 1-8 in sequence an additional 90° turn using a torque angle meter.

4) Rotate the remaining 11 mm bolts 9 & 10 in sequence an additional 50° turn using a torque angle meter.

5) Install the 8 mm bolt and tighten those bolts (11-15) in sequence to 22 ft.lbs. (30 Nm).
