DIESEL

Main Bearing Housing Bore For Caterpillar 10.0 & 12.0L C10 & C12 Diesel Engines

Main Bearing Housing Bore Caution For 1997-2007 Caterpillar C15 Diesel Engines

Coolant Loss On 1985-2000 Cummins 5.9L Diesel Engines

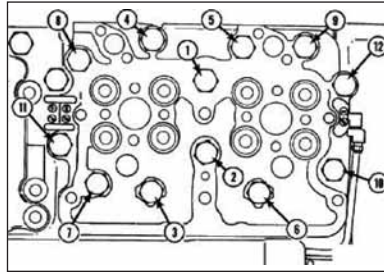
Because different cylinder head bolts have been used in Cummins, 14.0L N, NT and N14 diesel engines, the installation procedures may be different depending on the age of the head.

Figure 1 Cylinder head torque sequence for Cummins, 14.0L diesel engines.

When tightening the head bolts on N Series engines built before January 1991 and using head bolt, p/n 209700 or 3013623, the following procedure should be used.

- 1) 50 ft.lbs. [68 Nm]
- 2) 175 ft.lbs. [237 Nm]
- 3) 184 ft.lbs. [251 Nm]
- 4) Rotate all headbolts in sequence 90 degrees clockwise, at least one flat, but not more than two flats.

When tightening the head bolts on N Series engines built in January 1991 and later, and using head bolt, Part No. 3071161, 3068897, or 3068898, the following procedure should be used.

- 1) 100 ft.lbs. [136 Nm]
- 2) 220 ft.lbs. [298 Nm]
- 3) Rotate all headbolts in sequence 90 degrees clockwise, at least one flat, but not more than two flats.

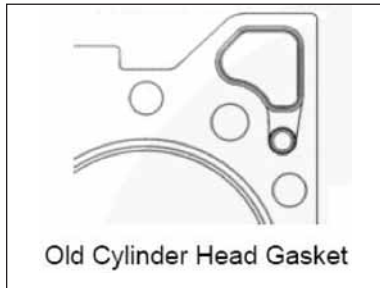
Old Cylinder Head Gasket

The old cylinder head gasket (p/n 4059350) included a one-piece steel carrier for the high pressure supply and low pressure oil return (**Figure 2**, page 32). The old gasket has been made obsolete and superseded by the new one (**Figure 3**, page 32).

Figure 2 Cummins ISX 600 Series - Old head gasket.

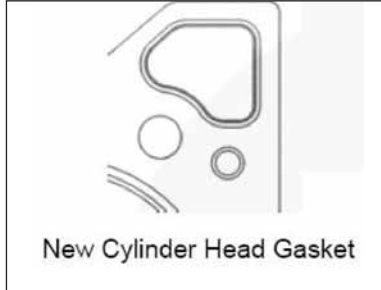
New Cylinder Head Gasket

The cylinder head gasket (p/n 4926316) contains two individual pieces, one for the high pressure oil supply and one for the low pressure oil return.

The first engine serial number (ESN) for the new cylinder head gasket is 79156618, built on January 20, 2006.

Figure 3 Cummins ISX 600 Series - New head gasket.
