Manifold Cleaning Caution On 1985-'96 Ford 1.9L VIN J Engines

Piston Oil Jet Removal & Installation Information For 1993-2002 Ford/Mazda 2.0L VIN A Engines

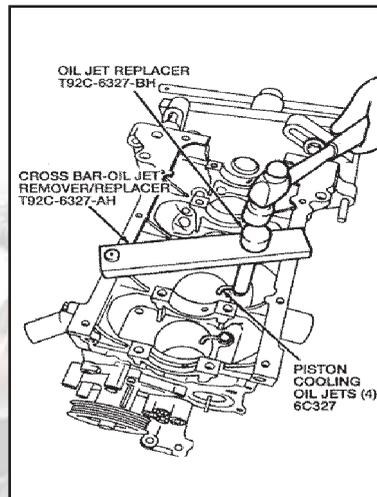
Figure 1 For easy oil jet removal/installation use these tools on Ford 2.0L engines

To facilitate easy removal and installation, special tools (p/n T92C-6327-AH and T92C-6327-BH) should be used (see **Figure 1**, right). It is also recommended that four new piston oil cooling jets (p/n 6C327) be installed as they're often damaged during removal. Some shops drill a small hole into the oil jet and then tap a screw into the hole, to which they attach a slide hammer for pulling the jet out.

During proper installation, each oil jet will align with each piston's taper cut-out. The jets are press-fit into the block with a minimum pressure of 726 lbs. (3.2 kN or 330 kgf). They also must be re-installed to a depth of .413"-.433" (10.50-11.00 mm) above the block mounting pad.

Caution: installation depth over specification can damage the oil jet nozzle. Pressure below specification indicates loose fit; replace the cylinder block and oil jet if that occurs.

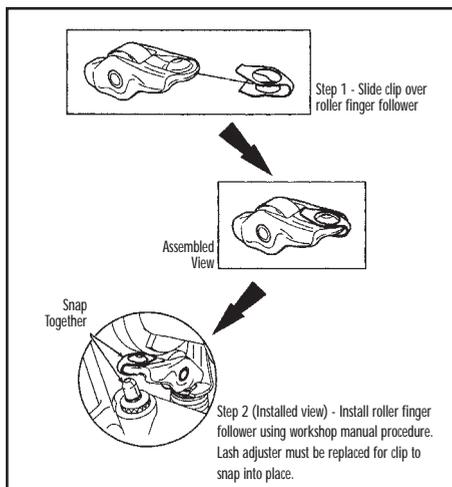
Figure 3 Inspect and replace any worn or damaged engine valve components and install new retaining clip and lash adjuster on Ford 4.6L, 5.4L and 6.8L engines.

be a roller finger follower(s) (RFF) being dislodged from the valve, which may cause damage to the camshaft, RFF, valve, retainer or other components.

Apparently, the clearance created in the lifters, at the locations with the valves remaining open when the engine is shut off, is sufficient enough to allow the dislodgement. Thicker oil during cold ambient temperatures may not allow fully pressurized oil to reach all locations during initial engine start-up. However, AERA recommends the following procedure be used to service this condition.

Inspect and replace any worn or damaged engine valve components and install new retaining clip and lash adjuster for service (**Figure 3**, above).

Remove all intake and exhaust lash adjusters from the engine and replace with service-only lash adjusters (p/n YL3Z-6500-AA). Refer to **Figure 3**, left, for installation of the new retaining clips (p/n YL3Z-6A539-AA), to the RFF.

The clip cannot be removed from the adjuster once it has been snapped into place. If the engine needs to be serviced at a later date, remove the RFF by bending up the clip. Leave lash adjuster in the engine with the clip while removing the follower. Then remove the lash adjuster from the head and snip/cut the clip from the lash adjuster. Replace with a new clip on the follower during re-installation.

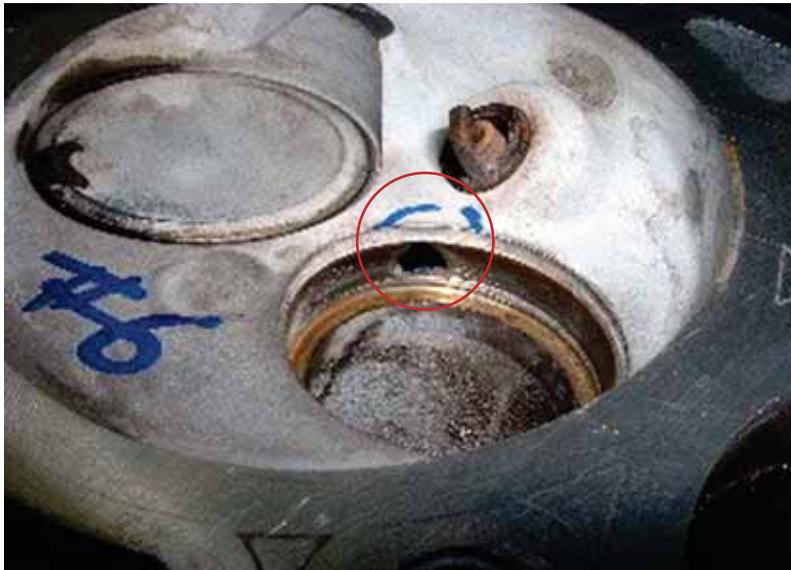
Figure 4 Hole exposed after removing valve seat on 1999-2003 Ford 5.4L engines.

Coolant loss and eventual engine overheating may have been caused by a pinhole located underneath an exhaust valve seat insert. At the time of publication this condition has been traced to a cylinder head with the casting number F75E6090C20A.

The pinhole has been found most often in the number 6 combustion chamber. However, don't limit your inspection to only that cylinder as others may also be affected. Many AERA shops have repaired this pinhole condition by removing the exhaust valve seat and welding the pinhole area. The repair is completed by re-machining for a new seat insert and returning the cylinder head to service after the valve job is completed.

sary: no cracks are usually shown and pinholes are generally invisible to the naked eye. But in severe situations, as shown in **Figure 4**, left, they can be easily seen if you know where to look for them. When checking these heads for coolant leaks, pressure testing is mandatory.

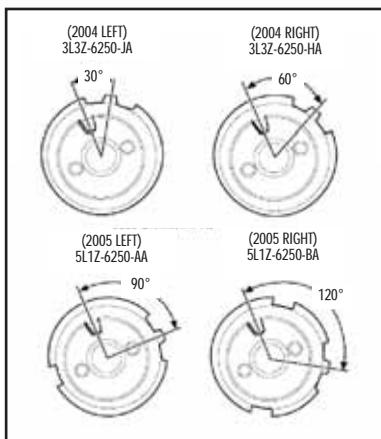
Because a camshaft and lash adjuster design change was made between the 2004 and 2005 Ford 5.4L 3-valve VIN 5 engines, using 2005 model year parts when servicing a 2004 model year or 2004 model year parts for a 2005 model year, the engine may exhibit noise on affected cylinders and engine damage may result.

Camshaft differences between the 2004 and 2005 model years can be identified by the location of the variable cam timing phaser (VCT) pin notch in relation to the machining lug as seen on the end of the camshaft shown in **Figure 5**, left.

Figure 5 Camshaft identification on 2004-'05 Ford 5.4L engines is made by location of the VCT pin. (Top) 2004 camshafts are shown; (Bottom) 2005 camshafts are identified.

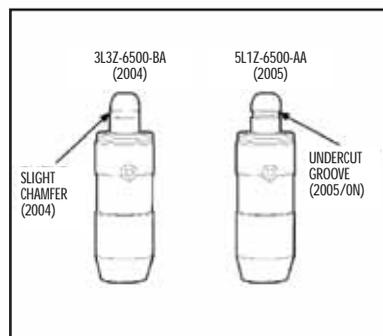
2004 and 2005 model year lash adjusters can be identified by the presence or lack of an identification groove cut into the lash adjuster boss shown in **Figure 6**, left. The 2005 model year parts will have this identification groove cut into the boss, while the 2004 model year parts will not.

Figure 6 A groove in the lash adjuster on 2004-'05 Ford 5.4L engines will identify 2004 or 2005 components.
