FORD MOTOR CO.

Sudden Loss of Oil Pressure For 1995-2005 Ford 2.0L VIN 3 and Z Engines

Crankshaft Pulley Replacement Caution For 2001-2007 Ford 2.0 and 2.3L VIN 3 and D Engines

Main Bearing Bedplate Installation Procedures For 2001-2006 Ford 3.0L VIN 1 Engines

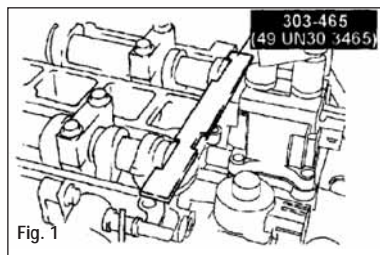
Fig. 1

1) Install the camshaft alignment plate 303-465 to the camshaft as shown in **Figure 1**, below.

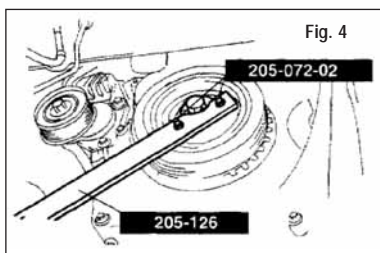
Fig. 4

4) Hold the crankshaft pulley using the service tools shown in **Figure 4** below

5) Tighten the crankshaft pulley lock bolt in the order shown in the following two steps using the service tool (49 D032 31 6).

- Tighten to 70.9 - 76.7 ft.lbs. (96 - 104 Nm) (9.8 - 10.6 kgf-cm)

- Tighten 87° - 93°

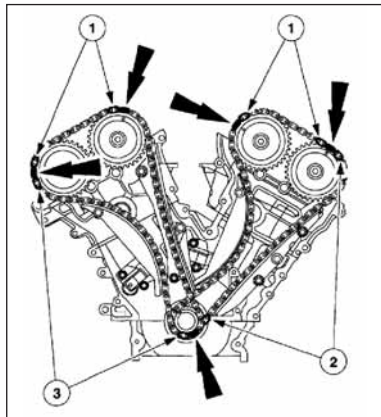
Figure 7 Chain Timed Positions

When the chains are properly positioned, the following should be noted, as referenced in **Figure 7** (right):

1) There should be 12 chain links between the front camshaft timing marks.

2) There should be 27 chain links between the camshaft and crankshaft timing marks.

3) There should be 30 chain links between the camshaft and crankshaft timing marks.

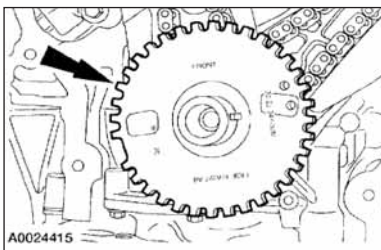
Figure 8 Install the Ford 3.0L engine ignition pulse wheel as shown

The pulse wheel, which is used in several different engines, should be installed with the keyway in the slot stamped "20-25-34Y-30M" (colored blue). Install the ignition pulse wheel as shown in **Figure 8** (below).

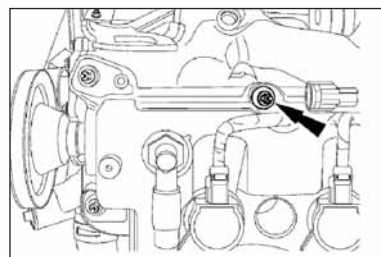
Figure 9 Left Hand Camshaft Area

Some 2005-2007 Five Hundred, Freestyles and Montegos; 2006-2007 Fusions and Milans; 2006 Zephyrs; and 2006-2007 Escapes and Mariners built 1/17/2006 and later equipped with the 3.0L 4V Duratec engine with exhaust camshaft driven water pumps may exhibit a ticking noise from the left bank cylinder

head with the engine at normal operating temperature.

With the engine running and warm (normal operation temperature), use a mechanic's stethoscope to determine if the ticking noise is coming from the left hand exhaust camshaft at cylinder number 6 (**Figure 9**, below). If a ticking noise can be verified, refer to the following service procedure:

1) Remove the left hand camshaft cover.

2) Rotate the engine clockwise

until the cylinder number 6 exhaust cam lobes are pointing up and the valves are fully closed.

3) Remove all left hand exhaust cam caps individually and reinstall them finger tight.

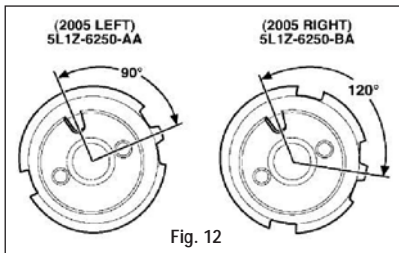
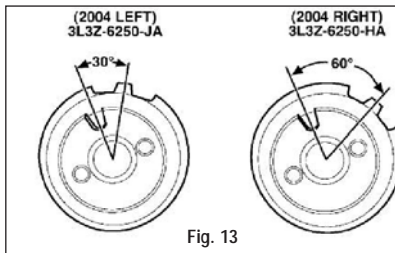
Figures 12, 13 and 14 Identifying the differences in the 2004-2005 Ford 5.4L camshafts and valve lash adjusters

2004 and 2005 MY camshafts can be identified by the location of the variable cam timing phaser (VCT) pin

notch in relation to the machining lug, as seen on the end of the camshafts (See **Figures 12** and **13** above).

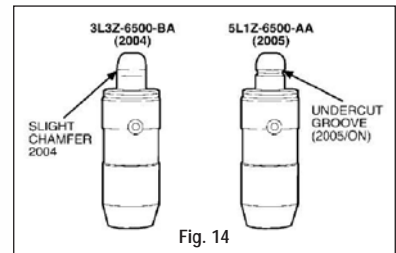
Fig. 14

2004 and 2005 MY lash adjusters can be identified by the presence or lack of an identification groove cut into the lash adjuster boss as shown below in **Figure 14**, above. The 2005 MY parts have this identification groove cut into the boss, while the 2004 MY parts don't. **TSG**
