Camshaft Sprocket Removal Tool Modification For 1995-2002 Chrysler 2.0L VIN C Engines

Cylinder Head Gasket Design Change For 2002 Chrysler PT Cruiser 2.4L VIN B Engines

Piston Skirt Clearance Caution On 1998-2002 2.7L VIN R Engines

Timing Chain Installation Procedure On 1998-2002 Chrysler 2.7L DOHC Engines

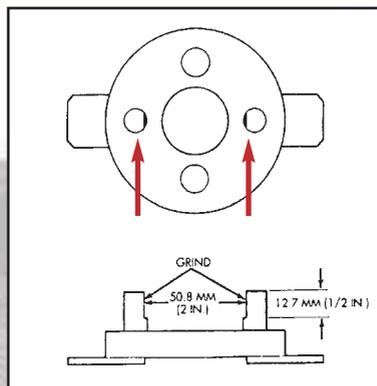
Figure 1 Grind the shaded area of the cam removal tool for use on Chrysler 2.0L engines.

Some rebuilders say it may be difficult to use the Chrysler supplied cam sprocket tool C4687 with these engines. The tool may require “fitting” for a particular cam sprocket to allow tool location and use. To modify the tool, reference **Figure 1**, right, and grind a small amount of material from the shaded areas shown. Doing so will provide a more useful tool.

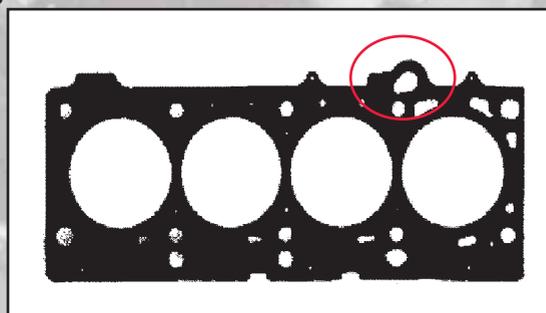
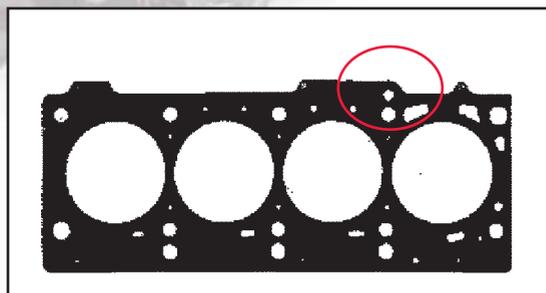
The design change to the cylinder head gasket was made to cover the new, larger crankcase ventilation hole. The hole, marked in **Figure 2**, bottom, is between cylinders No. 3 and No. 4 on the 2002 head gasket. Only one of the oil drain back holes on the fly-wheel side is opened from a round hole to a slightly larger irregular shape.

The original hole was much smaller and is the reason the gasket will not fit properly on the earlier 2001 and down cylinder heads and blocks.

Although the earlier 2001 gasket can physically be installed on the 2002 head and block, it will leak oil from the uncovered oil return/ventilation hole in the cylinder head when the engine is run. It will also block openings. The oil hole between the cylinders is not a high-pressure oil passage.

Figure 2 The 2002 Chrysler 2.4L head gasket (above) was revised for a larger oil drain hole. The circle indicates the revision.

The original hole (below) was much smaller and is the reason the new gasket will not fit properly on the earlier 2001 and down cylinder heads and blocks.

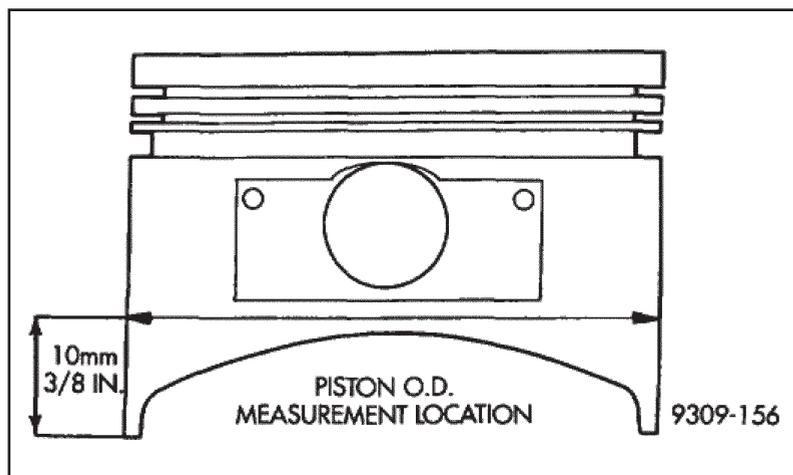
Figure 3 Measure the skirt clearance above the bottom of the piston skirt on Chrysler 2.7L engines.

Those values should be followed when assembling these engines with Chrysler pistons. Chrysler OEM pistons have an elliptical skirt and are coated with the solid film lubricant. When using those pistons, measure the skirt clearance at .390" (10 mm) above the bottom of the piston skirt as shown in **Figure 3**, above. The combination of the elliptical design features and coating may result in negative piston-to-bore skirt clearance.

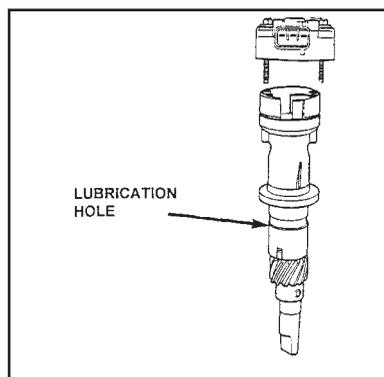
Figure 4 Remember to lubricate the shaft before installing camshaft sensor assembly on Chrysler/Jeep 4.0L engines.

In some instances the camshaft sensor has seized and requires replacement. When replacing the camshaft sensor pay particularly close attention that the cam sensor/oil pump drive gear on the camshaft is not damaged. If there are signs of sensor damage or camshaft gear damage, be sure to pull the oil pan and check for debris. Replacement of the cylinder block is not generally necessary when this condition occurs.

If the camshaft sensor assembly is being replaced, remember to lubricate the shaft before installation. To perform this pre-lube, turn the assembly upside down and squirt clean engine oil into the lubrication hole. It is located just below the mounting flange on the side of the housing (see **Figure 4**, top left). Also, rotate the shaft to ensure the upper bearing surfaces are lubricated properly. Failure to pre-lube the shaft and upper

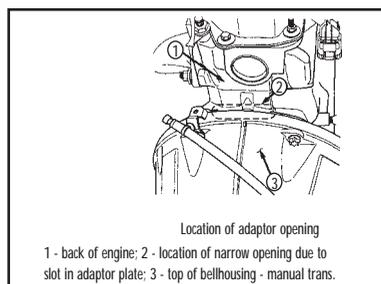
Figure 5 To repair rear main seal-leaks in Chrysler 4.0L engines apply liberal bead of RTV sealer to area.

There have been occasional reports of rear main seal leakage on 1997-2005 Jeeps with the 4.0L engine and a standard shift transmission built prior to 09/02/04. Closer inspection of suspect vehicles may reveal the cause of the engine oil seepage past the rear main seal is due to the accumulation of dirt and debris around the outside of the rear main seal.

A spacer plate is used to mate the transmission bellhousing to the back of the engine. The spacer plate has a slot machined into it at the 12 o'clock position. A small opening may occur as a result of the spacer slot when the spacer is mated between the engine and transmission bellhousing. This narrow spacer opening at the top may allow small size debris to accumulate around the outside of the rear main crankshaft seal. Vehicles used in dusty off road situations have been more severely affected.

as an abrasive while rotating on the crankshaft, damaging the seal and surface.

To prevent this from happening, seal the area shown in area 2 of **Figure 5**, left, when reinstalling a rebuilt or remanufactured remanufactured engines. Chrysler has suggested this type of repair be conducted after the rear seal and/or crankshaft has been repaired by applying a liberal bead of RTV sealer to the area. Make sure to thoroughly clean the area before applying the sealer.
