New Fractured Connecting Rod For 1989-2005 Caterpillar C7, 3114, 3116 & 3126 Engines

Main Bearing Bolt Torque Caution On '97-2005 Cummins ISX Signature 600 Series Engines

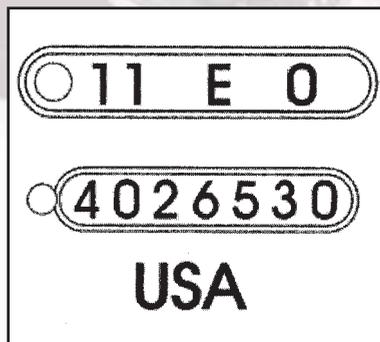
Engines that were manufactured up to engine serial number 79012120 can be identified with the letters "USA" (**Figure 2**, below) included in the stamping located just below the water pump. The torque value for those main bearing cap bolts is 110 ft.lbs. + 180°; use the sequence in **Figure 3** (below) for proper torque sequence.

Figure 2 Cummins ISX 600 engine identification stampings.

Newer engines that were manufactured after serial number 79012120, can be identified by "MEX" and the pyramid mark stamped just below the water pump. The torque value for those main bearing cap bolts are 300 ft.lbs. + 90° using the sequence in **Figure 3** for proper torque sequence.

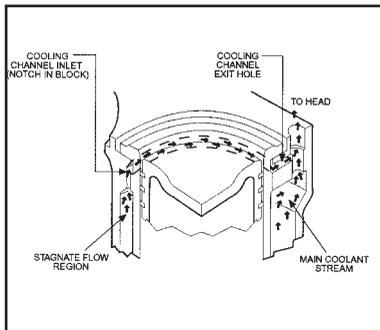
The AERA Technical Committee offers the following information regarding an enhanced top liner cooling on Detroit Diesel 60 Series engines. This feature, an option at the time of purchase, shown in **Figure 4**, page 32, was introduced to increase cooling to the top of the liner with serial number 6R59715.

Figure 4 Enhanced top liner cooling feature on Detroit Diesel 60 Series engines.

To provide the benefits of the top liner cooling to engines built prior to 1994, a kit to retrofit these blocks is available (p/n J39582). Carefully follow the following procedure when converting a non-top liner cooling block to a top liner cooling block.

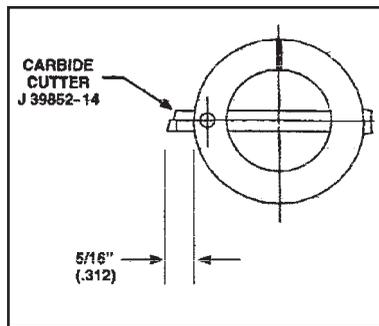
Figure 5 Install bronze washer on the feed unit shaft and attach cutter holder assembly to shaft.

cutter into the holder, position it as shown in **Figure 5**, above.

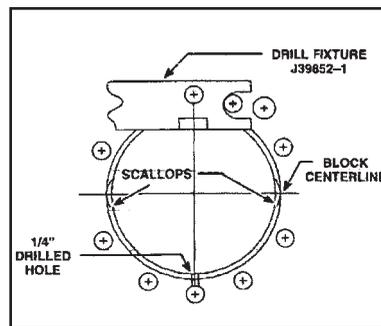
Figure 6 Rotate the mounting plate 180° until it lines up with the next set of cylinder head bolt holes

and by hand rotate the cutter away from the work. Remove the two mounting bolts and washers and rotate the mounting plate 180° until it lines up with the next set of cylinder head bolt holes as shown in **Figure 6**, above. Repeat steps until block is completely done.

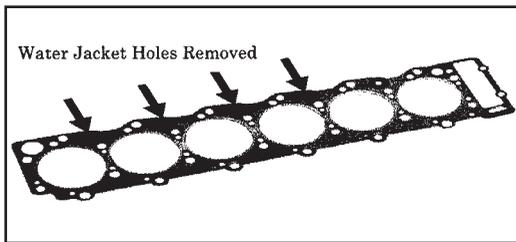
Figure 7 The current head gasket design for Isuzu 7.1L engines has four blocked-off water coolant passages as compared to the original gasket.

A new replacement cylinder head gasket for the 6HE1-TC diesel engine is currently available from the American Isuzu Parts Distribution Network (AIPDN). This new cylinder head gasket (p/n 8-94395-447-1), differs slightly from the original design. The difference between previous and the current gasket are very apparent visually and have prompted many questions from technicians who are re-assembling the engine. The current design, as shown in **Figure 7**, above, has four blocked-off water coolant passages as compared to the original gasket.

The holes were eliminated to improve coolant flow in the cylinder head and the new gasket replaces the original gasket p/n 8-94393-372-1.

When ordering a replacement cylinder head gasket, be sure to refer to the new part number listed in this bulletin. At the time of this publication AERA is unaware of an after-

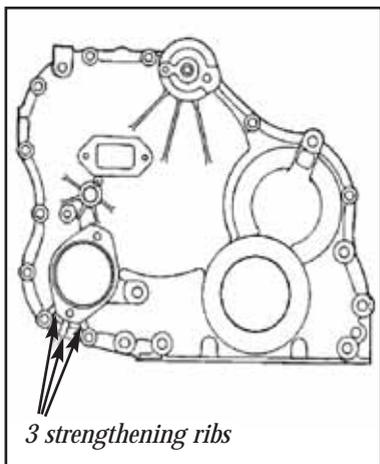
The AERA Technical Committee offers the following information regarding a revised timing cover for 2004-2005 Mack E-Tech™ 12.0L diesel engines. This revision was made to strengthen the power steering pump mounting flange to help reduce breakage and cracking on certain applications, particularly for engines used in vehicles equipped with the heavier Vickers model V20 power steering pump.

To provide strength, additional metal was added to the power steering pump mounting flange on both the inside and outside of the timing gear cover. With this change, the timing gear cover part number has been changed to p/n 333GB5131BM.

The most noticeable feature of this new timing gear cover is the three strengthening ribs located at the bottom of the pump-mounting flange as shown in **Figure 8**, (page 34).

Figure 8 Extra strengthening material was added to the Mack 12.0L timing cover.

This revised timing gear cover was implemented into production early November 2004 for ASET™ AI/AMI engines and early December 2004 for ASET™ AC engines. The timing gear cover is also available through the Mack Parts System as a replacement for any existing cover that has cracked in the area of the power steering pump mounting flange on ASET and E-Tech engines.

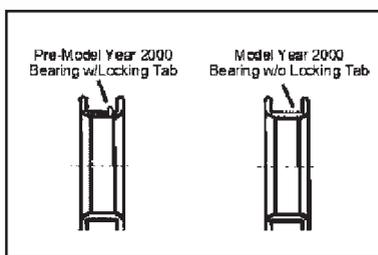
The AERA Technical Committee offers the following information regarding a revised lower thrust bearing for 2000-2005 Navistar 7.6L and 8.7L diesel engines. Some service technicians have been confused while reassembling the crankshaft into engine blocks for the above engines because the lower thrust bearing shell has no locating lug.

This unwarranted confusion is the result of a revised bearing introduced with the model year 2000 engines. The new lower thrust main bearing (#7 position only) was released for production and service for ease of installation.

Figure 9 Pre-2000 and revised main bearings for Navistar 7.6L and 8.7L engines.

service bearing allows the lower thrust bearing to be installed and oriented in either direction (see **Figure 9**, above). Service bearing for lower main bearings 1-6 and crankcase (upper 1-7) continue to require bearings with the locking tab feature.

The modified bearing is interchangeable with engines released before the Model Year 2000 engines. Model Year 2000 engines are identified by serial number 1194039 and above. Service bearings are available in standard and three common undersizes. **EB**
