Remanufactured Engine Caution For 1.9L DOHC Saturn Engines

Cylinder Head Bolt Caution On 2001-'02 GM 2.2L VIN F Engines

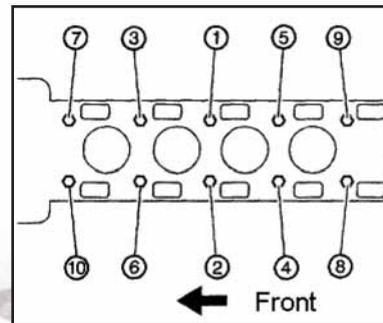
Saturn service manuals may have the incorrect torque listed for 2001-2002 GM 2.2L VIN F engines, says AERA's Technical Committee.

Figure 1 2001-'02 GM 2.2L Head bolt torque sequence.

If the published torque is used, cylinder head bolts may break. Previously published head torque had an additional 185° added to the torque. The correct torque for this engine should be 22 ft.lbs. + 155°. Any time the cylinder head is taken off of this engine, cylinder head bolts must be replaced. Follow the torque sequence provided in **Figure 1**, above.

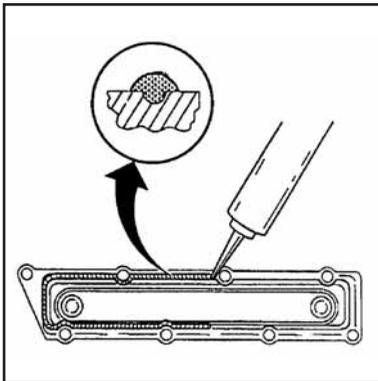
Customers/installers may complain of a low coolant light being on and/or engine overheating on 1997-2001 GM 3.0L VIN R engines, which was used in the Cadillac Catera. A leaking oil cooler cover due to an adhesion condition between the cover and the engine block may cause this condition.

Figure 2 Apply around oil cooler on '97-2001 3.0L GM engines.

Remove the oil cooler cover from the engine and the old sealant from the engine block and the oil cooler cover. Use only a plastic or metal scraper to remove the old sealant residue. Clean both surfaces using a solvent that will not leave any residue on those surfaces.

Apply a .080" bead of sealant (p/n 2378521; Canada use p/n 88901148 or equivalent), in the groove around the engine oil cooler cover as shown in **Figure**

Install the engine oil cooler cover back to the engine block and torque to 22 ft.lbs.

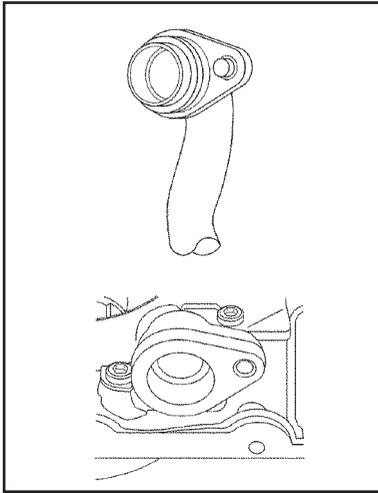
The first design (**Figure 5**, page 22) was used in production for 2002-2003 and part of 2004 model year and used an O-ring type seal between the pick-up tube and the front cover. The second design (**Figure 6**, page 22) was used during production model year 2004

Any time the front cover or oil pick-up tube is serviced, be sure to identify which design is being serviced. The correct pick-up tube must be used with its corresponding front cover or an engine failure could result.

Figure 5 Oil pick-up tube for GM 4.2L 2002-'03 and part of 2004 (first design).

Any vehicle requiring a new front cover must be serviced with the second design front cover; therefore, the engine oil pick-up tube must be replaced at the same time.

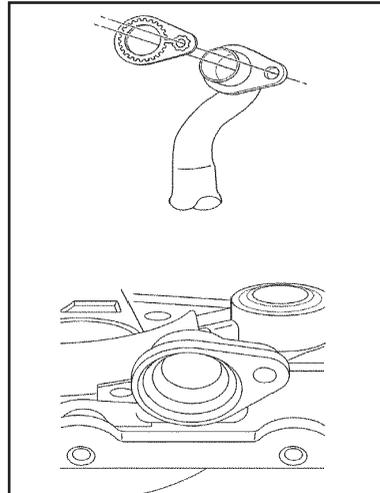
and uses a face-type seal for the pick-up tube.

Figure 6 Oil pick up tube for 2004 GM 4.2L with face type seal (second design).

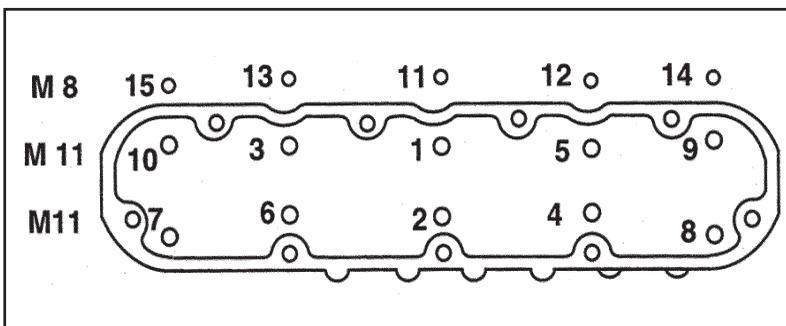
This procedure (**Figure 7**, below) should be used any time the cylinder head is being installed and supersedes information found in earlier published service manuals.

Figure 7 Cylinder head torque sequence for 5.7L GM engine using 8 mm and 11 mm head bolts.

reuse the 8 mm head bolts and it is now recommended all cylinder head bolts should be replaced at the time of cylinder head installation. The new 11 mm bolts come with a pre-applied sealer and lubricant and no other sealant should be used on them.

1) Tighten new 11 mm bolts (1-10) in sequence to 22 ft.lbs. (30 Nm).

2) Rotate those bolts (1-10) in sequence an additional 90° turn using a torque angle meter.

3) Rotate only bolts 1-8 in sequence an additional 90° turn using a torque angle meter.

4) Rotate remaining 11 mm bolts 9 and 10 in sequence an additional 50° turn using a torque angle meter.

5) Apply a .200" (5 mm) bead of locking compound (GM p/n 12345382 or equivalent) to the new 8 mm bolt threads, and tighten bolts (11-15) in sequence to 22 ft.lbs. (30 Nm).

Do not re-use either the 8mm or 11mm head bolts. **EB**
