Revised Timing Belt Tensioner

2002-2003 Acura 3.2L SOHC Engines
A revised timing belt tensioner for 2002-2003 Acura 3.2L engines is part of a product improvement by Acura.

Cylinder Head Gasket Leak On 1988-95 1.6L Honda Civic Engines

Camshaft Identification For 2001-2003 3.0L & 3.5L DOHC Hyundai Engines

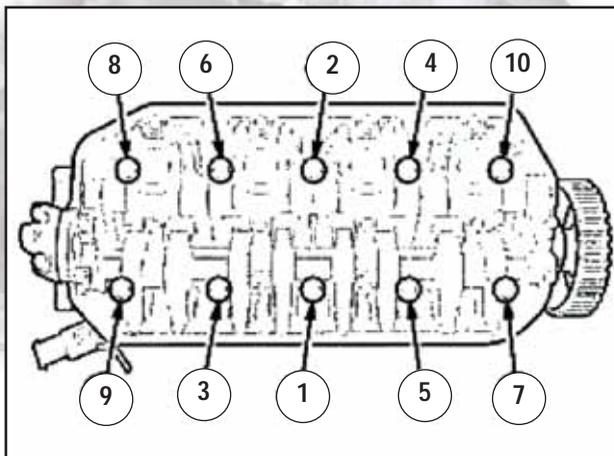
You or your supplier customers may have received complaints that oil is leaking externally or there is coolant loss on 1988-'95 1.6L Honda Civic engines due to a cylinder head gasket leak. This information does not apply to the VTEC engines.

Figure 2 Torque sequence for 1988-'95 1.6L Honda Civics (non-VTEC). Oil leaks and coolant loss may be eliminated by using an MLS head gasket.

This information also supersedes Honda service bulletin 97-047, dated September 29, 1997. The current corrective action prescribed by Honda involves installing a new MLS cylinder head gasket (p/n 12251-P01-004) and 10 new head bolts (p/n 90005-PM3-004). It is important to note that the following torque

4) Apply engine oil to the threads and washers of the new cylinder bolts. Install the bolts, and torque them in the sequence and steps shown in **Figure 2**, below. Do not use the head bolt tightening steps in the Honda service manuals.

5) Step 1. Tighten all 10 bolts in sequence to 14 ft.lbs. (20 Nm).

Step 2. Tighten all 10 bolts in sequence to 36 ft.lbs. (49 Nm).

Step 3. Tighten all 10 bolts in sequence to 49 ft.lbs. (67 Nm).

Step 4. Tighten bolts 1 and 2 to 49 ft.lbs. (67 Nm) again.

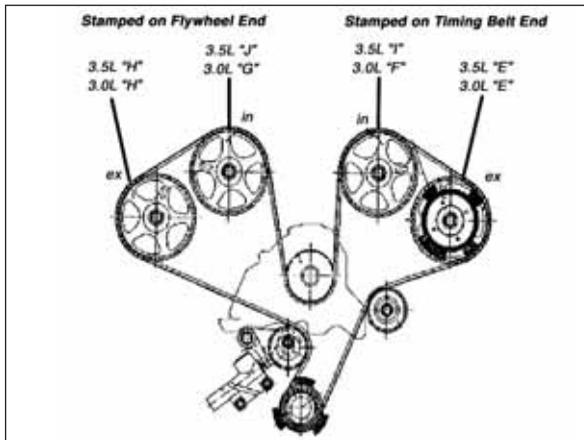
Figure 3 Hyundai camshafts are etched with a letter on the end for identification.

Caution: while the camshafts all have letters cast in between the lobes with RI, RE, LI, LE, these casting letters are meaningless and should NOT be used to determine camshaft location.

Each camshaft for the 3.0L and 3.5L engine is etched with a letter on the end of the camshaft to identify the location the camshaft should be mounted in. The letter should be read while held in the "6 o'clock" position and viewed with a good working flashlight. Use the illustrations in **Figure 3**, above, for identification and location.

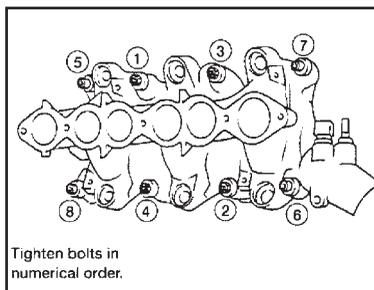
Figure 5 Nissan 3.3L intake manifold torque sequence.

and in the numerical order as shown in **Figure 5**, below. Use the specified angle wrench – ST10120000 (J24239-01) – as necessary.

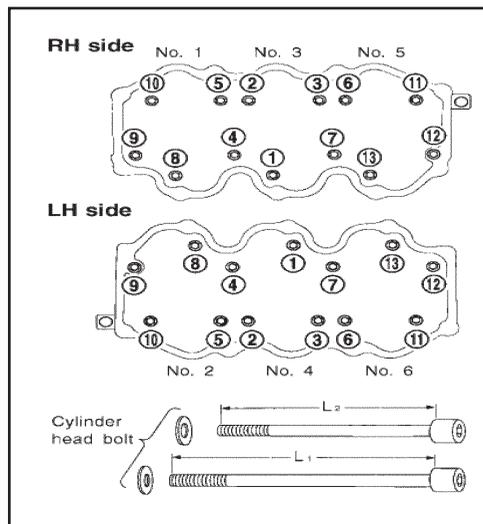
Figure 4 Install the washers between the bolts and cylinder head with the washer beveled side up on Nissan 3.3L engine.

2) Install the washers between the bolts and cylinder head with the washer beveled side up as shown in **Figure 4**, right.
