CHRYSLER

Fix is a Snap for 2.0L, 2.4L Chrysler Engines with High-Pitched Noise

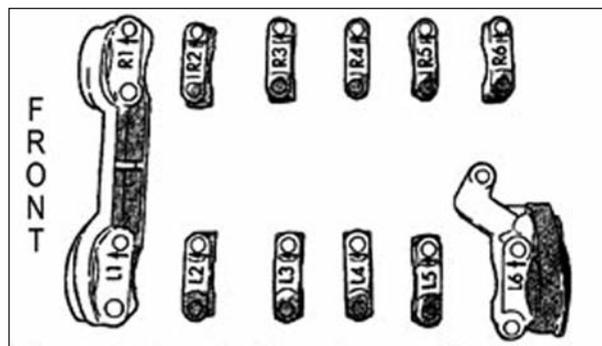
The noise may occur when the vehicle is in park, and the engine is running between idle and 1,400 rpm at normal operating temperature. The sound is heard at the upper end of the engine (cylinder head) toward the right front side (passenger side), and is irregular, not periodic or harmonious. The frequency of the noise will increase with rpm. The sound is more of a high-pitched "snapping" noise than a low metallic knock.

Figure 1 Remove cylinder head valve cover on Chrysler 2.0L and 2.4L engines, then remove L2 cam bearing cap.

If the customer describes the noise and the installer determines that the sound is coming from the described location, the repair procedure involves chamfering the bore radius on cam bearing caps L2 through L5 and R2 through R5.

2. Remove L2 cam bearing cap (see **Figure 1**).

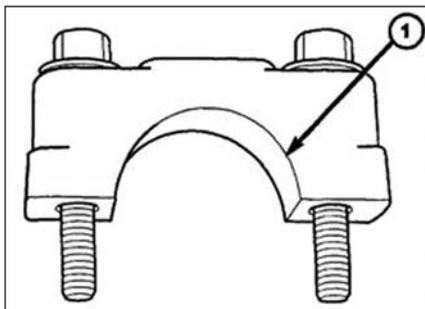
Figure 2 Lightly chamfer bore radius edges on 2.0L, 2.4L engines with a hand file, creating a 45° chamfer along the edge of each bore radius.

3. Lightly chamfer the two bore radius edges with a small hand file, creating a 45° chamfer 1.0 to 1.5 mm in width along the edge of each bore radius (see **Figure 2**).

Caution: Be careful not to scratch the bore surface of the cam bearing cap(s). Chamfer both bore radii.

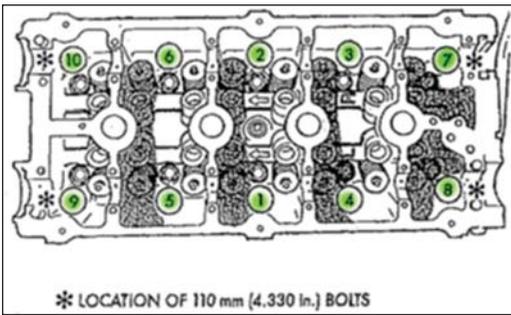
Figure 3 Torque sequence for 2.0L DOHC with MLS gasket installation. The 4 short bolts are placed in the corners of the block (marked with an asterisk).

Note: The 4 short bolts are placed in the corners of the block (marked with an asterisk in **Figure 3**, which also explains torque sequences).

A. Torque all center bolts to 25 ft.lbs. (34 Nm); torque the 4 corner bolts to 20 ft.lbs. (27 Nm).

B. Torque all center bolts to 50 ft.lbs. (68 Nm); torque the 4 corner bolts to 35 ft.lbs. (47 Nm).

C. Re-torque all center bolts to 50 ft.lbs. (68 Nm); re-torque the 4 corner bolts to 35 ft.lbs. (47 Nm).

D. Tighten all bolts in the specified sequence (Fig 1) an additional 90° (1/4 turn).

1. Using a six inch wobble plus extension friction ball and shallow socket following the torque sequence shown in **Figure 3**, loosen one bolt at a time to 0 torque and then torque that same head bolt to 60 ft.lbs.

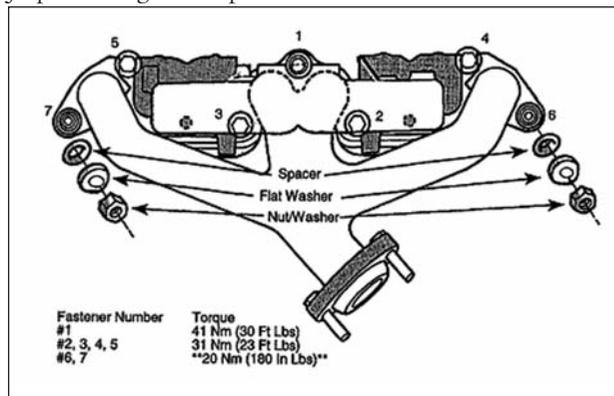
Some outer exhaust manifold exhaust studs are breaking due to fatigue on 1991-1999 Jeep 2.5L engines. Inspect either manifold

Figure 4 Replace both outer mounting studs, clamps and nuts on Jeep 2.5L engines with new parts and tighten the outer studs to a reduced torque of 180 in.lbs.

This procedure involves replacing both outer mounting studs, clamps, and nuts with new parts and tightening the outer studs to a reduced torque of 180 in.lbs. (20 Nm).

6. Torque the bolts in the order and specification as listed in **Figure 4**.

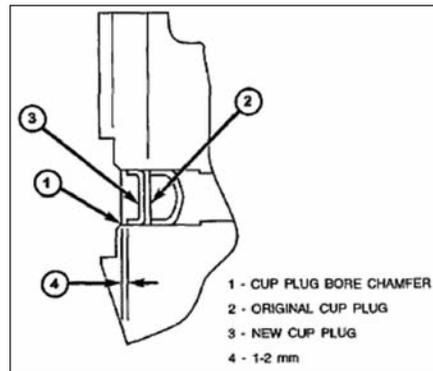
Figure 5 Drive the new cup plug on 2.7L engine into the bore until the flanged edge of the plug is just inside (1-2 mm) the chamfered edge of the bore.

4. Using an appropriate installation tool drive the new cup plug into the bore until the flanged edge of the plug is just inside (1-2 mm) the chamfered edge of the bore (Figure 5).

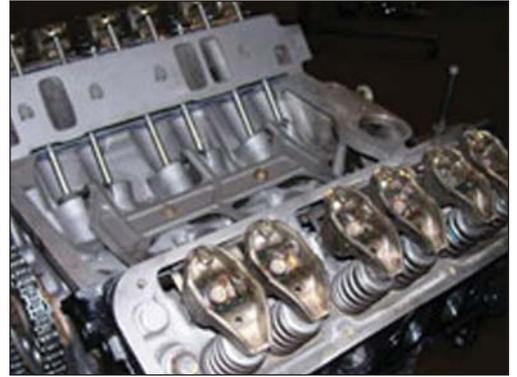
If the intake manifold plenum pan gasket is leaking, a vacuum source will be created in the engine. Any engine blow-by and outside filtered air will be drawn past the leaking pan gasket and into the intake manifold. In most cases, an engine at idle will create the highest vacuum and lowest amount of engine blow-by.

Figure 6 Oil leaks on some Dodge V6, V8 engines may not leak externally. The intake manifold plenum pan gasket has been revised to address this condition.

The intake manifold plenum pan gasket has been revised to address this condition (see Figure 6).

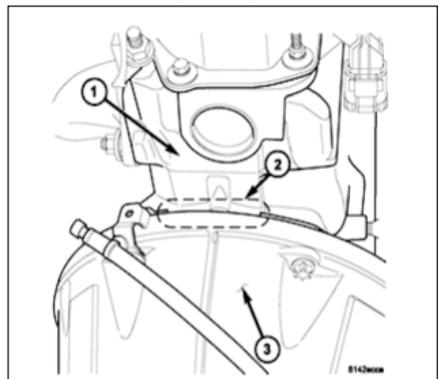
Figure 7 The spacer opening at the top of Jeep 4.0L bellhousings may allow very small debris to enter the bellhousing and accumulate around the outside of the rear main seal.

machined into it at the 12 o'clock position. A small opening may occur at the spacer slot when the spacer is mounted. The narrow spacer opening at the top of the transmission bellhousing may allow very small debris to enter the bellhousing and accumulate around the outside of the rear main engine seal. If debris accumulation becomes significant, damage to the rear main seal may result.

1. Locate the narrow opening created by the spacer plate (see **Figure 7**). The spacer opening can be seen when looking toward the rear of the engine and top of the transmission.

3. Apply a sufficient amount of RTV over the spacer opening. Verify that the spacer opening is completely sealed off by the RTV.

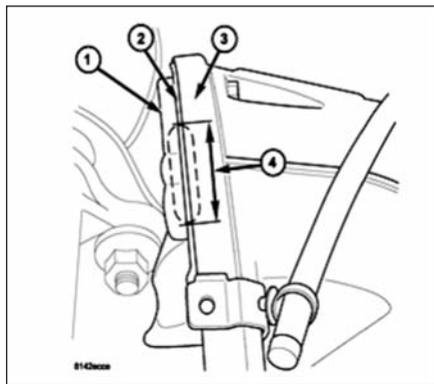
Figure 8 Thoroughly clean the immediate area around 4.0L spacer opening with throttle body cleaner and allow to dry.

2. Thoroughly clean the immediate area around the spacer opening with throttle body cleaner (p/n 04897156AA). Allow cleaner to dry (see **Figure 8**).

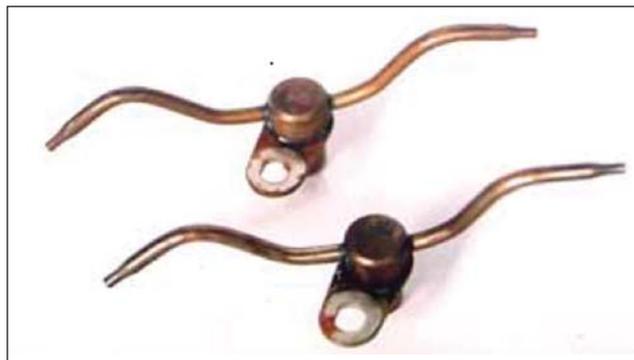
5. Note the oil pressure as it may read 1 to 2 psi less than in step 2. If this is the case, the whine may be heard. If the procedure is followed closely, the whine can be turned on and off with a slight change to oil pressure. The piston cooling jets (see **Figure 9**) are operating properly but high oil temperature results in slightly lower operating oil pressure at idle and can cause the valve inside the oil cooler jets to flutter.

Figure 9 A whine sound may be present at idle after vehicles with 6.1L Hemi engines have been driven in warm ambient temperatures over 50° F (10° C). This sound can be caused by the piston oil cooler jets fluttering during hot oil/idle conditions.

If a customer complains about this sound, first reassure him or her that no detrimental effect on engine durability is caused by the jets fluttering. If the customer wants this noise eliminated, Chrysler recommends the use of 15W50 Mobil One engine oil in warmer (summer) months and revert back to 0W40 Mobile One engine oil in cooler months. If the oil viscosity is changed, a label indicating this should be installed. **TSG**
