TECH SOLUTIONS GUIDE

FORD MOTOR CO.

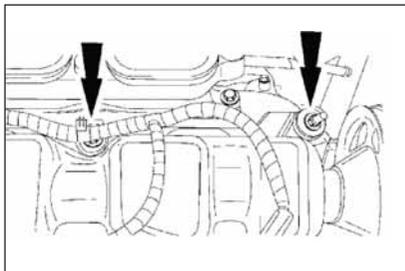
Figure 1 Cam cap listening points for 2001-'06 3.0L Ford engine.

Some 2001-2005 Taurus/Sable, 2001-2006 Escape and 2005-2006 Mariner vehicles built prior to 1-17-2006 and equipped with the 3.0L 4V Duratec engine may exhibit a ticking noise from the left bank cylinder

head, only when the engine is at normal operating temperature.

The ticking noise may be coming from the left hand intake camshaft at cylinder No. 6. Your installer customers can easily diagnose this condition, with the engine running at normal operating temperature, using a mechanic's stethoscope (**Figure 1 left**). If the ticking noise can be veri-

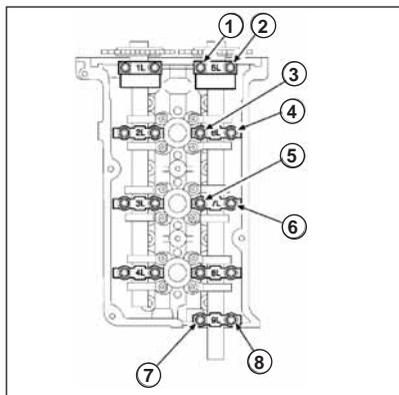
Figure 2 Torque sequence for 2001-'06 3.0L Ford engine.

4) Torque bolts in sequence shown in **Figure 2** (below) to 72 in.lbs. (8 Nm) excluding No. 8L camshaft cap.

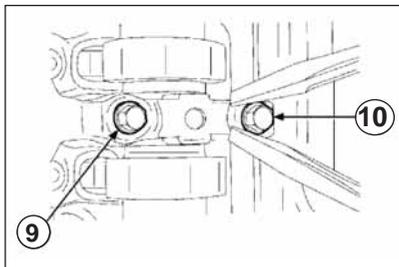
Figure 3 Apply pressure and shift cap No. 8L toward exhaust side on 3.0L engines.

5) Using a screwdriver positioned on each side of the top of cam cap No. 8L (**Figure 3**, below) apply hand pressure and shift cam cap No. 8L toward the exhaust side of the cylinder head.

6) While holding cam cap No. 8L in the shifted position, torque the fasteners, No. 9 (inboard) first, to 72 in.lbs. (8 Nm) then torque fastener No. 10 to 72 in.lbs. (8 Nm) (**Figure 3**).

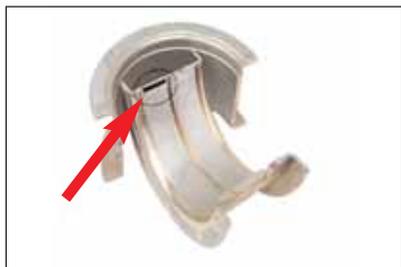
When a problem application is encountered, every effort should be made to find the cause of distress and correct it before completing repairs or you risk a repeat failure.

Figure 6 Increase parting line inside chamfer to approximately .040" from groove to rear only 4.2L and 5.0L engines.

Use a small, fine toothed, flat file to increase the chamfer on the ID edge of the bearing parting line from the oil groove to the rear thrust face only (see **Figure 6**, below). This enlarged ID chamfer will allow pressurized oil from the bearing oil groove to reach the loaded thrust face without passing through the bearing's clearance space first. Since there is a load against the rear thrust face, the load should restrict oil flow and there should not be a noticeable loss in oil pressure. Although this modification is not a guaranteed cure-all it should help if all other conditions, such as surface finish,

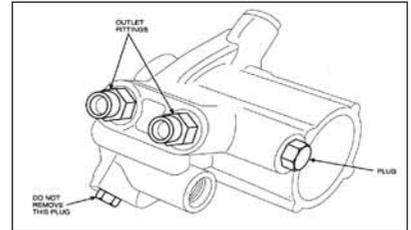
Figure 11 7.3L engine oil pump fittings.

The AERA Technical Committee offers the following information regarding high pressure oil pump leakage on 1998-2003 Ford 7.3L VIN F diesel engines. Some 1998-2003 E-Series, 1999-2003 Super Duty, 2000-2003 Excursion and 2000-2003 F650/750 vehicles equipped with a 7.3L Diesel engine may exhibit an oil leak at the high pressure oil pump outlet fittings and/or end plug (see **Figure 11**, above right).

This type of leak may appear to be a rear main crankshaft seal, oil pan gasket, or other engine oil leak due to the drain hole machined in the crankcase valley which allows any oil in the valley

to run down the back of the engine.

High pressure oil pump leaks at the outlet fittings and/or end plug can be serviced without removing the pump assembly. Replace the three O-rings on the fittings and the end plug using Kit 2C3Z-9G804-AA. Apply liquid thread sealer (included in the kit) prior to reinstallation.

Note: do not remove the bottom plug. **TSG**

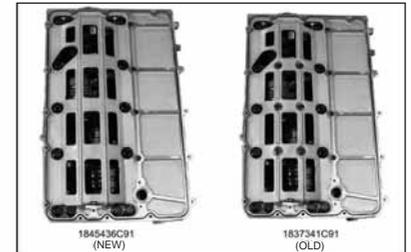
This new upper oil pan assembly has retained the offset and removed the center bosses with mounting bolt holes (see **Figure 10**) page 7. The new assembly is compatible with all

Figure 10 6.0L diesel Truck, RE, SFC Bus, and Stripped Chassis upper oil pan assembly.

engines using upper oil pan with offset feature. The old mounting bolts (M6 x 25) can be reused. The old center boss mounting bolts (M8 x 40) can be discarded.
