Revised Camshaft Sprocket Bolt Torque for 1996-1999 VW/Audi 1.8L AEB Engines

Water Pump Coolant Leaks On 1990-2006 Suzuki Engines

Crankshaft Pulley Replacement Caution For 2001-2005 Mazda 2.0 & 2.3L Engines

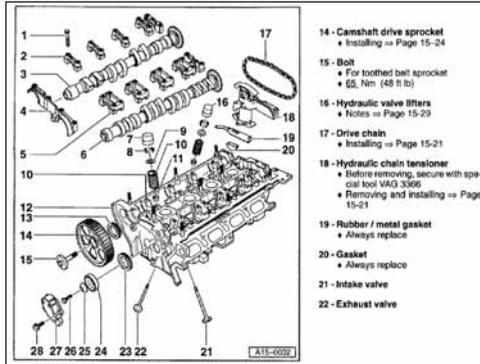
Previously published service information regarding camshaft sprocket bolt torque specifications for the 1.8L Volkswagen/Audi 1.8L AEB engines may have incorrectly listed the torque value at 74 ft.lbs.

The correct torque value for the camshaft sprocket bolt is 48 ft.lbs. (65 Nm). These cylinder heads are beginning to be seen in machine shops because many miles have accumulated since they were new.

If the incorrect torque value is used, the result may be engine failure. Even if the bolt does not break after over-torquing,

it is possible that all engine valves (20) will bend/break if the head bolts fail while engine is running (**Figure 1**, left).

Figure 1 Previously published service information for 1.8L Volkswagen/Audi 1.8L AEB engines may have incorrectly listed camshaft sprocket bolt torque at 74 ft.lbs. Correct bolt torque is 48 ft.lbs.

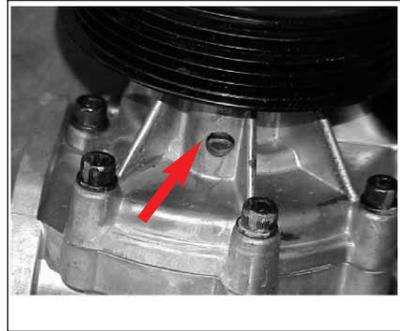
Figure 2 Water pump coolant leaks on 1990-2006 Suzuki engines.

The AERA Technical Committee says that water pump coolant leaks on all 1990-2006 Suzuki engines may be a normal part of the break-in cycle. Numerous water pumps have been returned to Suzuki under warranty due to leaks, however after testing these pumps they've been determined satisfactory for service.

Suzuki has determined that signs of coolant leakage at water pump weep holes are normal during break in. For a period of time some coolant will pass through the seal and leave green and white deposits around and below the weep hole (see **Figure 2**, above). This is not detrimental to the function of the water pump.

There is however a limit to what is considered normal leakage, according to the company.

found around the weep hole and this area is not leaking, do not replace the water pump.

- If these deposits of coolant are found and coolant is visibly leaking from the weep hole enough to drip on to the ground, replace the water pump.

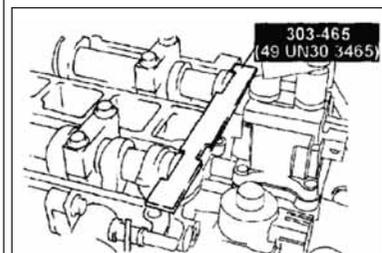
Figure 3 Install the camshaft alignment plate on 2.0 and 2.3L Mazda engines.

The AERA Technical Committee offers the following information regarding the crankshaft pulley replacement for 2001-2005 Mazda 2.0L and 2.3L engines. The crankshaft pulley is NOT KEYED to the crankshaft on these engines.

If the crankshaft pulley bolt is loosened, the pulley may move position on the crankshaft. The engine MUST be re-timed whenever the crankshaft pulley bolt is loosened, removed or replaced. Several service tools are required to correctly re-time all the components.

1) Install the camshaft alignment plate 303-465 to the camshaft as shown in **Figure 3** (page 24).

2) Install the M6 x 1.0 bolt by hand as shown in Figure 3.

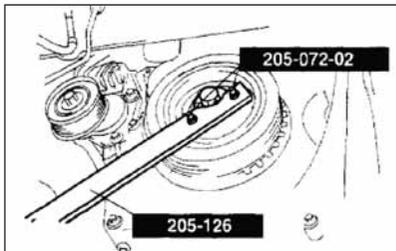
Figure 4 Tighten the crankshaft pulley lock bolt on 2.0L and 2.3L Mazda engines.

4) Hold the crankshaft pulley using the service tools shown in **Figure 4**, above.

5) Tighten the crankshaft pulley lock bolt in the order shown following two steps using the service tool (49 D032 31 6).

- Tighten to 70.9 - 76.7 ft.lbs. (96 - 104 Nm)
 - Tighten 87° - 93°
- 6) Remove the M6 x 1.0 bolt.
7) Remove the service tool from the camshafts.

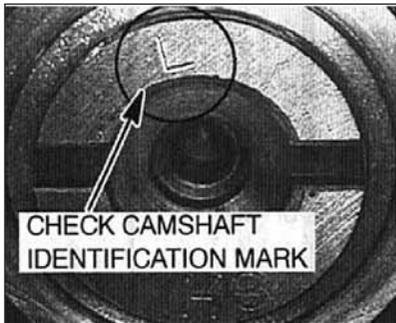
Figure 5 To identify the cam on 2004 Mitsubishi 2.4L engines, look at the slotted cam end for either a letter "L" or "G."

The AERA Technical Committee says Mitsubishi's published information seems to have listed incomplete specifications as two different camshaft profiles were used. The following information regarding the correct valve lash specification and camshaft identification for 2004 Mitsubishi 2.4L SOHC, G69M engines may be helpful.

You must identify which camshaft is being used to obtain the correct valve lash specifications. To identify the cam, examine the slotted cam end and look for either a letter "L" or "G" as shown in **Figure 5**, above left.

Lash adjustments can be slightly different for the two different cam profiles. **Chart 3**, above, can be used once you've correctly identified which cam you have.
