GENERAL MOTORS

Engine Failure and Close-Coupled Cat Converter Information For 2004-2007 GM Vehicles

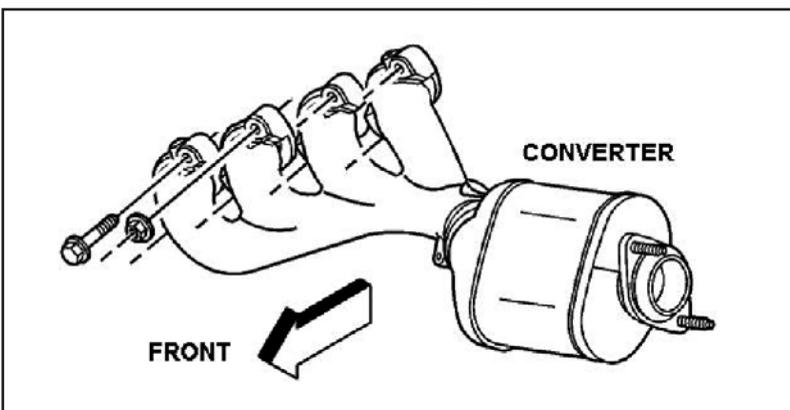
If an engine breakdown or non-function were to occur (such as broken intake/exhaust valve or piston), debris may be deposited in the converter through the engine exhaust ports. If the engine is non-functioning due to severe overheating, damage to the ceramic "brick" internal to the catalytic converter may occur. This may result in ceramic debris being drawn into the engine through the cylinder head exhaust ports.

Figure 1 Close-coupled catalytic converters on GM vehicles may become damaged after certain engine failures.

Therefore, when replacing an engine, an inspection of the catalytic converters and ALL transferred components (such as exhaust/intake manifolds) should be performed. Any debris found should be removed. In cases of engine failure due to severe overheating, installers should also inspect each catalytic converter for signs of melting or cracking of the ceramic "brick." If damage is found, the converter should be replaced.

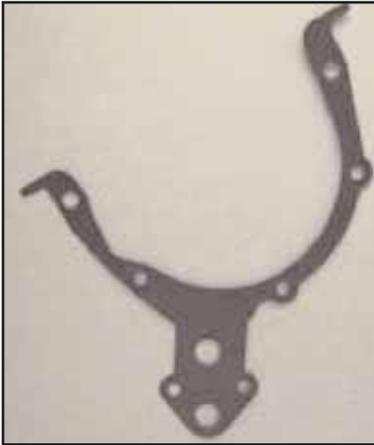
The oil pump-to-engine block gasket may leak near the top of the oil pump assembly, resulting in a leak that spreads oil on the front of the engine and oil pump. Technicians may misdiagnose the source of the leak and unnecessarily replace the oil pump along with the gasket if they are unable to determine the exact location of the oil leak.

The oil pump gasket may develop a crack that cannot withstand high oil pressure under operating conditions. GM has developed a new metal-reinforced oil pump gasket (p/n 90573301) that should be used anytime the oil pump is removed (**Figure 2**, page 8). RTV sealant should not be used when installing a new gasket.

Figure 2 GM has developed a new metal reinforced oil pump gasket for 2004-2006 1.6L engines.

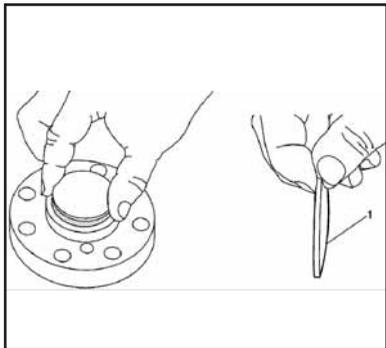
This leak from the rear of crankshaft is due to porosity problems in the crankshaft. GM offers the following solution to the problem.

Figure 3 Install service cup plug dish side out on GM 4.2L crankshafts. Do not drive plug in place with impact socket and hammer as damage may result.

Position the crankshaft service cup plug into the crankshaft flange bore with the service cup plug, dish side outward (**Figure 3**, page 9). Note: Do not use an impact socket with hammer to drive the service cup plug into place. Damage to the crankshaft thrust bearing may result.

When completed, remove installation tool assembly and confirm the installation depth of the service cup plug. Place a straight edge across the center of the crankshaft flange as the measurement point. Measure from the straight edge to the center of the installed cup plug. The depth of the installed cup plug should be 16-17 mm (.630"-.670").

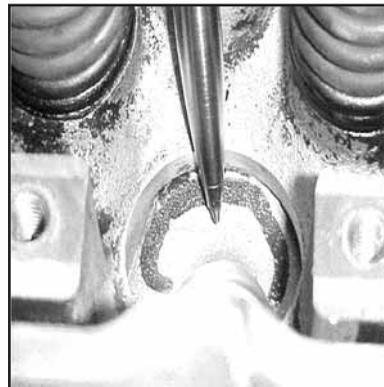
A possible coolant leak may exist between the cylinder head valve guide bore and the interior of the cylinder head casting, or a porosity condition may exist on certain Castech castings (as shown in **Figure 4**, right). Under pressure while the cylinder head casting is hot, coolant may collect in the leaking areas of affected heads and if allowed to continue, eventual oil and coolant mix-

Figure 4 A possible coolant leak may occur between the cylinder head valve guide bore and the interior of the cylinder head casting on GM 4.8 and 5.3L engines.

ing will occur, resulting in engine damage.

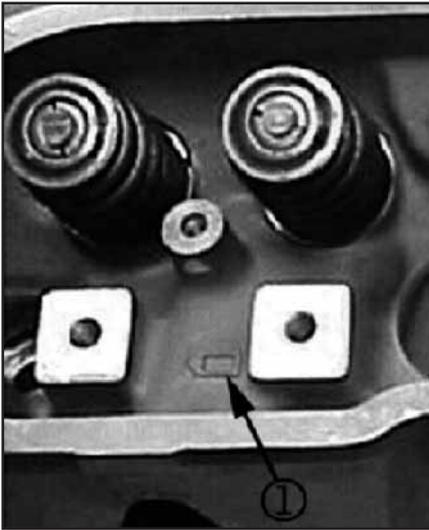
Figure 5 A porosity condition may exist on certain Castech castings. Above arrow shows Castech logo found on some GM 4.8 and 5.3L engines.

manufactured by Castech, inspect the inside corners for a logo such as the one shown in **Figure 5**, left.

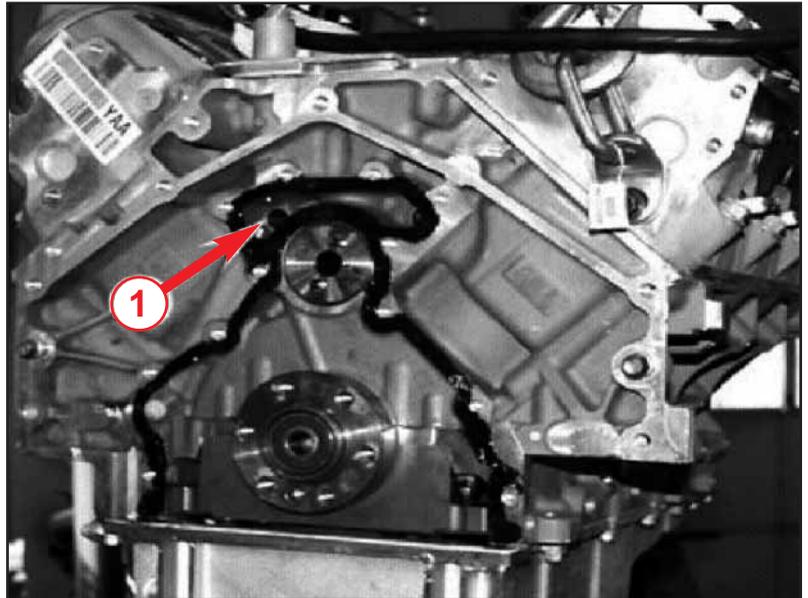
Figure 6 An oil leak on 2003-'06 GM 4.8, 5.3, 5.7, 6.0 and 7.0L engines may suggest that the leak seems to be coming from the rear cover gasket area.

While an initial investigation of a rear engine oil leak on 2003-'06 GM 4.8, 5.3, 5.7, 6.0 and 7.0L may suggest that the leak seems to be coming from the rear cover gasket area, this condition may actually be caused by engine block porosity on the engine block sealing surface.

If the leak is found to be coming from the rear cover gasket area (see **Figure 6**, page 11), remove the cover

and inspect the cylinder block for any indications of porosity in the sealing areas. If porosity is found anywhere on the sealing surface, use RTV p/n 8-12778-521-0 to fill in any porosity locations.

Wipe a small amount of the RTV sealant onto the surface using a plastic scraper to fill in the porosity holes on the mating surface of the cylinder block. Remove any excessive RTV that may have been applied, especially from the high-pressure oil passage as shown with arrow in picture below.

Allow the RTV to cure 10 minutes before installing the rear cover. When installing the rear cover, tighten the engine rear cover bolts to 18 ft.lbs.
