# IMPORT

## Crankcase Ventilation System Check For 1994-2007 BMW Engines

## Cylinder Head And Timing Belt Update On 2006-07 Hyundai 2.0L VIN D Engines

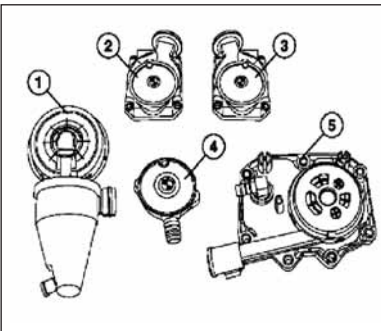
Although the valves all look different, they function similarly using a spring and diaphragm assembly to control the crankcase pressure. A properly functioning pressure control valve is designed to maintain a

**Figure 1** Various BMW crankcase ventilation valves: No. 1, used in the M52/S52 engines; Nos. 2 and 3, used in the M73 (two valves per engine); No. 4, used in the M42 from 1/94 production and M44; and No. 5, used in the M60/M62.

slight vacuum (approximately 10 - 15 mbar) in the crankcase which ensures reliable crankcase venting during all engine operating conditions.

If a crankcase ventilation valve is defective (damaged diaphragm) the column of water will indicate an off the scale reading (all of the water on one side of the slack tube) which indicates a high crankcase vacuum.

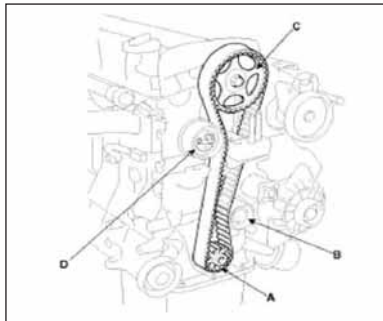
**Figure 4** Hyundai 2.0L timing belt installation.

2) Install the timing belt over the applicable sprockets in this order. See **Figure 4**, page 25: Crankshaft Sprocket (A) Idler Pulley (B)

Camshaft Sprocket (C) Timing Belt Tensioner (D). Ensure there is no slack in the belt between the two shafts.

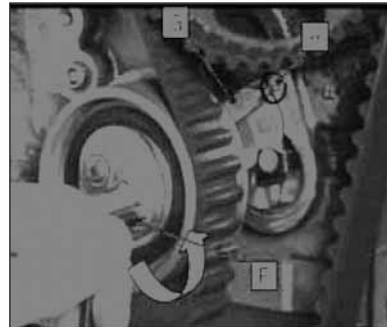
**Figure 5** Hyundai 2.0L tensioner bolt torque.

5) Using a 6mm hex wrench (F), turn the adjuster counterclockwise to make the indicator of the arm (G) line up with the notch on the base (H) and tighten the tensioner bolt. See **Figure 5**, page 25, (Torque to 16-21 ft.lbs., 22-28Nm)

Do not rotate the tensioner clockwise as it will permanently damage the tensioner.

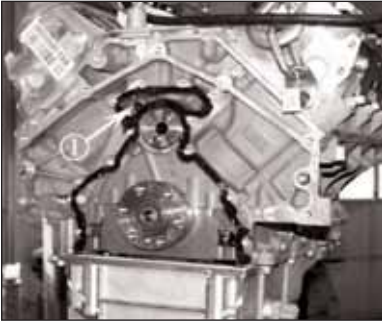
A rear engine oil leak on 2003-2006 Isuzu Ascenders with 5.3L VIN P engines that upon initial diagnosis seems to be coming from the rear cover gasket area, may actually be caused by engine block porosity on the engine block sealing surface.

**Figure 6** Rear engine oil leak on Isuzu Ascenders 5.3L engines.

If the leak has been determined to be coming from the rear cover gasket area, remove the cover area and inspect the cylinder block for any indications of porosity in the sealing areas. If porosity is found anywhere on the sealing surface, use RTV p/n 8-12778-521-0 to fill in any porosity locations.

the mating surface of cylinder block. Remove any excessive RTV that may have been applied, especially from the high pressure oil passage as shown with arrow in picture below. Allow the RTV to cure 10 minutes before installing the rear cover. When installing the rear cover, tighten the engine rear cover bolts to 18 ft.lbs.

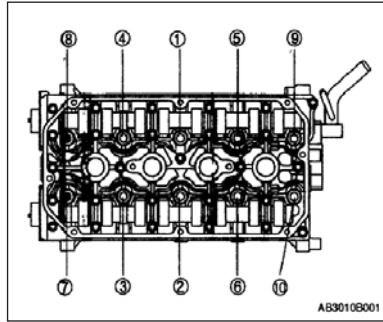
The torque values published in the 2001-2002 Rio Service Manuals for the 2001-2002 Kia 1.5L DOHC engine are incorrect.

The manual incorrectly specifies the cylinder head bolt torque values as 36.1 in.lbs. and 18 in.lbs. respectively (before a final 90 degree tightening step). While the values are correct, the units should read ft.lbs. The 2002 manual states to rotate the head bolts two additional 90° turns, only once is correct. The correct listing should read as shown below. Use the head bolt torque sequence in **Figure 7**, page 26, as a reference.

**Figure 7** KIA 1.5L torque sequence. Use the revised torque specification.

- Torque all bolts in sequence to 36.1 ft.lbs.
- Loosen all bolts in reverse sequence.
- Torque all bolts in sequence to 18 ft.lbs.
- Rotate all bolts in sequence an additional 90° turn.

Also note that the cylinder head bolts used on Rio engines are the (stretch) type that must not be reused, they must be replaced any time they are removed.

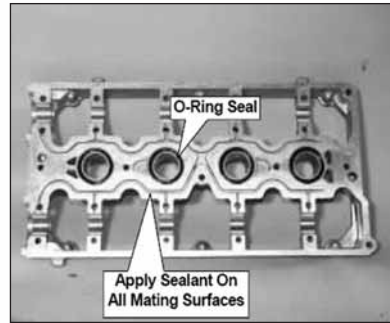
Kia inadvertently specified sealant to be used on outside surfaces only. This is incorrect. Sealant should be applied to all mating surfaces, while taking care not to allow

**Figure 8** Use Hylomar adhesive on KIA 1.5L cam carrier.

The specified sealant is for close fitting machined surfaces, and eliminates the need to re-torque after the sealant settles and cures. The sealant to be used when replacing or re-installing the Rio's cam carrier is either Hylomar Anaerobic Adhesive

Grade 3000 or an equivalent, such as Permatex Anaerobic Gasket Maker. See **Figure 8**, above.

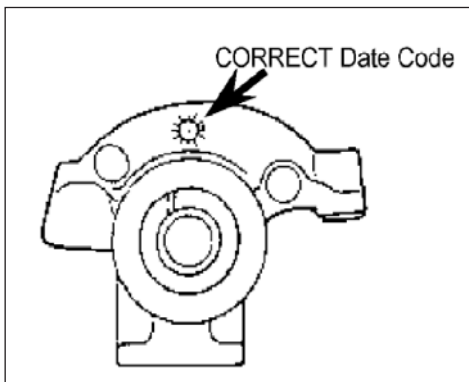
Customer complaints of a rattling/tapping noise from the engine found to originate from rocker shaft area may be the result of the hardened pushrod cup being insecure in the rocker arm.

**Figure 9** Range Rover rocker arm.

Investigate customer complaints of valve rattling/tapping noise on vehicles within the above VIN ranges and identify rocker arms with loose pushrod cups. If noisy or loose rocker arms are encountered during the inspection, replace all rocker arms with updated parts.

Only rocker arms with date codes '00' or newer (01) may be used to repair valve trains. Use of early production rocker arms may result in a recurrence of the problem (**Figure 9**, above).
