# FORD MOTOR CO.

## Revised Cylinder Head Gasket and Head Bolts for 1983-92 Ford 2.3L OHC

## Diagnosing Ticking Noises in 2005-'08 3.0L Ford Duratec Engines

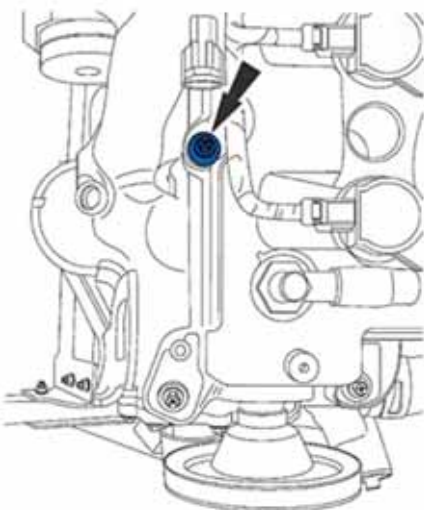
There have been some complaints of a ticking noise in the left bank cylinder head engine area in certain late model Ford Duratec engines. Refer your engine installer to the following service procedure to identify and resolve the issue.

To diagnose, with the engine running and warm (at normal operating temperature), use a mechanic's stethoscope to determine if the ticking noise is coming from the left-hand exhaust camshaft at

cylinder #6 (see **Figure 1**, below). If the ticking noise can be verified, refer to the following instructions.

**Figure 1** Verify the ticking noise is coming from the left-hand exhaust camshaft at cylinder #6.

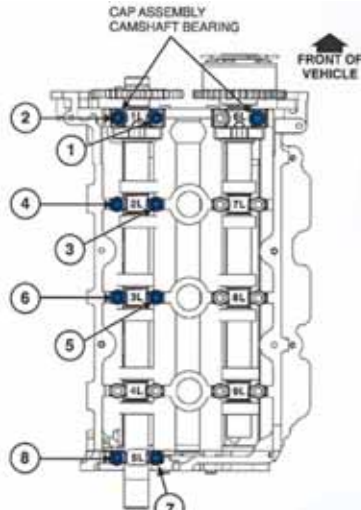
**Figure 2** Torque bolts in sequence to 72 in.lbs., excluding cam cap #4L camshaft cap.

- 4) Torque bolts in sequence as shown in **Figure 2**, below, to 72 in.lbs. (8 Nm), excluding #4L camshaft cap.

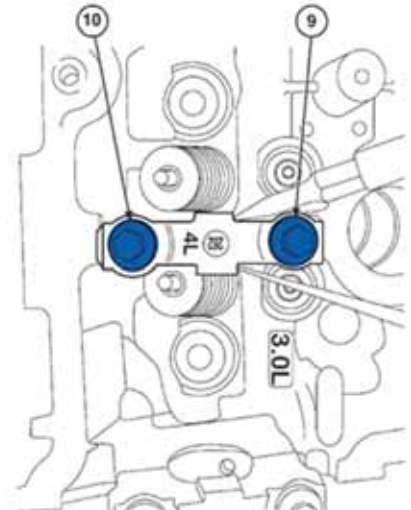
**Figure 3** Torque fastener #9 (inboard) first, to 72 in.lbs., then torque fastener #10.

**Figure 2** page 12), apply hand pressure and shift cam cap #4L toward the exhaust side of the cylinder head.

6) While holding cam cap #4L in the shifted position, torque fastener #9 (inboard) first, to 72 in.lbs.. (8 Nm), then torque fastener #10 (**Figure 3**, page 12).

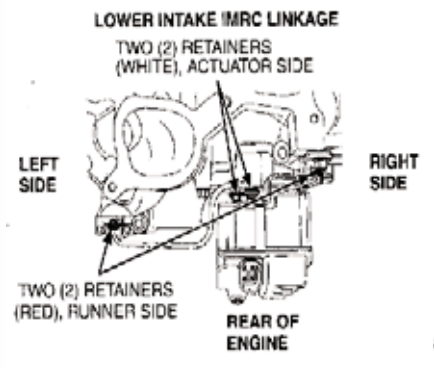
Some Ford vehicles equipped with 3.8L, 3.9L or 4.2L engines with Split Port Intake Manifold Runner Control (IMRC) may exhibit spark knock under light load and acceleration. Follow the service steps to correct this condition.

**Figure 4** If any actuator rod linkages are found disconnected, replace all four linkage rod retainers.

4) If any IMRC actuator rod linkages are found disconnected, replace all four linkage rod retainers (**Figure 4**, below).

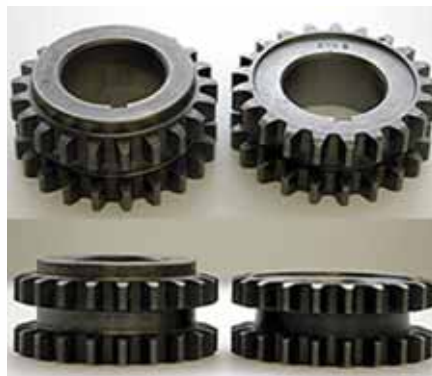
Back in 2001 on the 4.6L (although this is a split year) and in 2002 on the 5.4L, Ford made some changes to the timing gear set, specifically the crankshaft gear (the two-piece gears seen in the early years have all been replaced by the one-piece). There was a shorter gear set used prior to the dates listed above and a longer gear after those dates (see **Figure 5**, below).

The crank position trigger wheel changed as well. The early wheel that goes with the short gear is a PM trigger that has a spacer flange cast right into it. The later wheel, which is stamped steel, is flat and used with the tall gear.

**Figure 5** A shorter gear set was used prior to 2001/'02 and a longer gear after those dates.

4.6L in 2001 (the split year) you could end up with the late gear and the early crank position trigger, or vice versa, neither of which will work in combination.

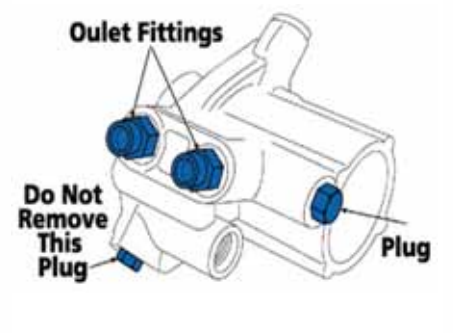
**Figure 6** 7.3L engines may leak at the high-pressure oil pump outlet fittings and/or end plug.

E-Series, 1999-2003 Super Duty, 2000-'03 Excursion and 2000-'03 F-650/750 vehicles equipped with a 7.3L diesel engine may exhibit an oil leak at the high-pressure oil pump outlet fittings

and/or end plug.

According to Ford, this type of leak may appear to be a rear main crankshaft seal, oil pan gasket or other engine oil leak due to the drain hole machined in the crankcase valley which allows any oil in the valley to run down the back of the engine (see **Figure 6**, page 14).

High-pressure oil pump leaks at the outlet fittings and/or end plug can be serviced without removing the pump assembly. Replace the

O-rings on the fillings and the end plug using kit 2C3Z-9G804-AA. All three O-rings should be replaced. Apply liquid thread sealer (included in the kit) prior to reinstallation.

Note: Do not remove the bottom plug on the oil pump – it is sealed in a different manner. **TSG**

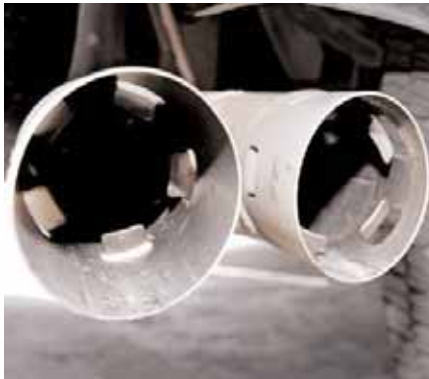
These exhaust tips should not be removed or covered with dress sleeves that will seal off the ports on the sides (see **Figure 7**, page 15). As you can see, the new generation of diesel engines from all makes will have some odd-

The tips are designed to draw cool air into the tip, by use of venturi action, to cool the exiting gases during filter regeneration.

During filter regeneration mode, the exhaust temperatures are more intense than normal. Without the special tips, the exiting gases become hazardous to the paint on the truck's body, dry grass that might catch fire or someone's legs who happens to be standing too close to the tail pipe.

**Figure 7** These exhaust tips should not be removed or covered with dress sleeves that will seal off the ports on the sides.
