GENERAL MOTORS

Revised Cylinder Head Torque Specs for GM 3.1L and 3.4L Engines

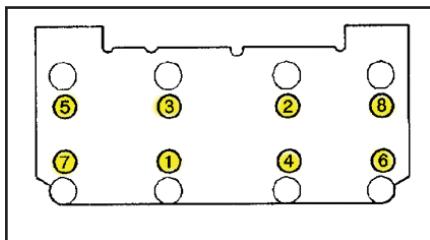
Figure 1 Follow this order to torque GM 3.1L and 3.4L heads to their proper specifications.

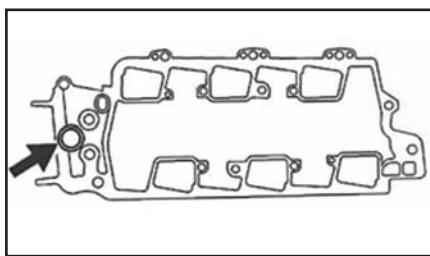
Figure 2 Look for degradation of the upper intake manifold composite material.

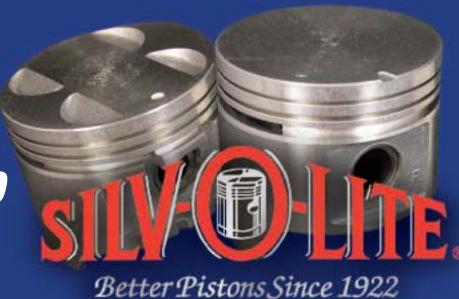
- Over 485 OE replacement pistons for auto, light trucks, popular imports, and heavy duty applications
- Coated skirts
- Floating wrist pins where applicable
- Application specific aluminum alloys

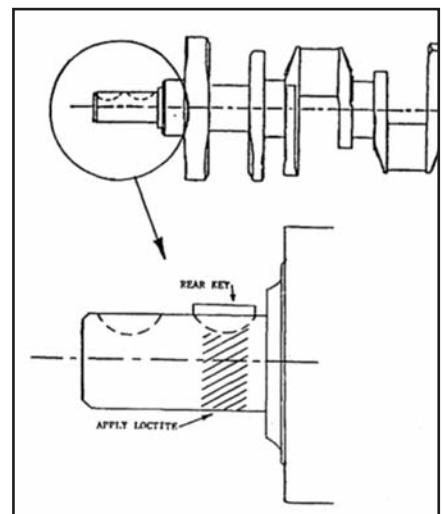
Figure 7 The thread locking material should not be applied to the sprocket inside diameter but to the crankshaft post for 360 degrees at the rear crankshaft key area only.
