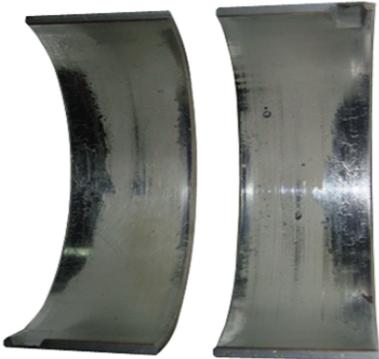
Bent or twisted connecting rod

Detonation or high torque at low rpm may cause distortion of the rods, which excessive localized wear near the bearing edge.

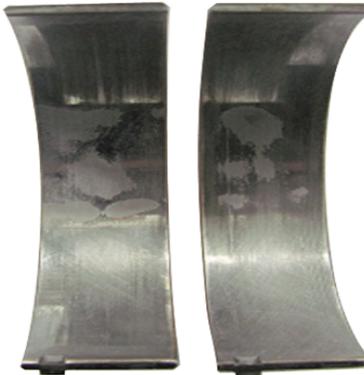
Cavitation erosion of the overlay

Cavitation bubbles form and collapse as a result of localized, sharp drops in oil pressure and flow.

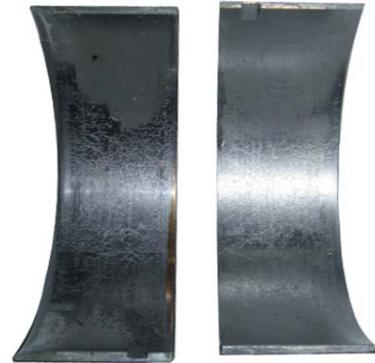
Fatigue of overlay

This condition appears in the form of a network of thin cracks. Thinner overlays form thinner fatigue cracks.

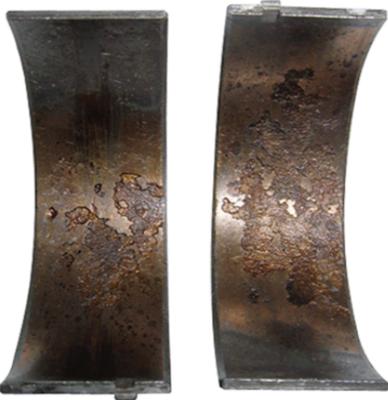
Fatigue of copper based lining

Here the overlay flakes out from the copper lining, resulting in a breakdown of the oil film thickness.

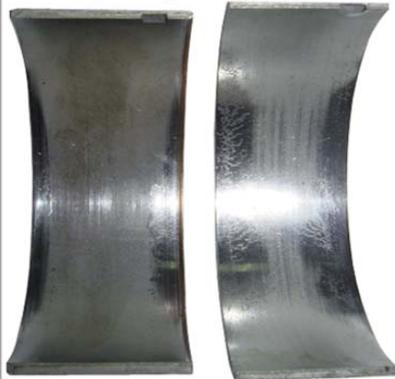
Imperfect journal geometry

This could result from using a worn stone when grinding a crankshaft, making the journal out of shape or with taper.

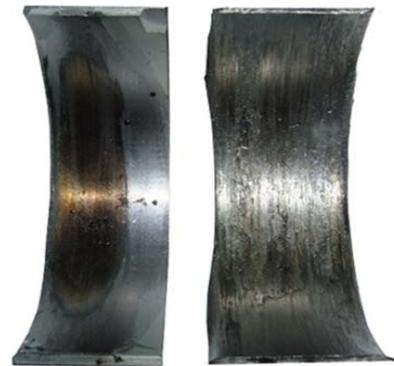
Metal-to-metal contact

This condition may be due to oil starvation, misalignment, poor journal surface, or foreign particles embedded into the surface.
