July 2001

# ENGINE BUILDER

# Rebuilding the Toyota 3.0L V6 SOHC Head

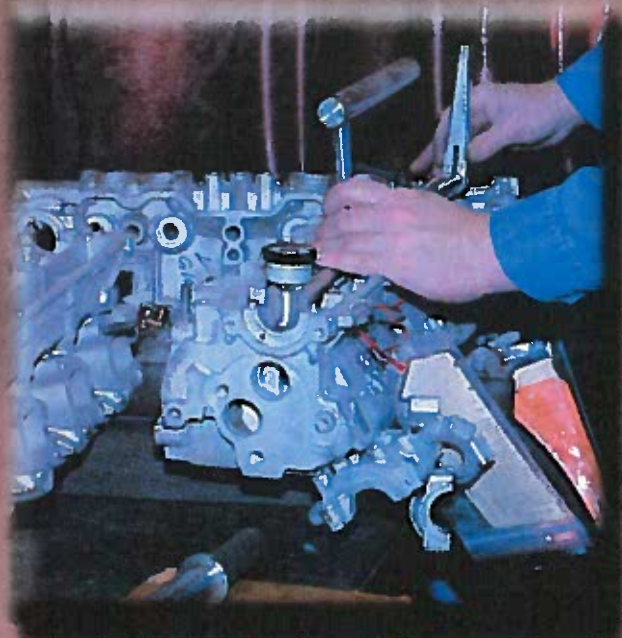
*Checking a Toyota 3VZ head cam bore for straightness; .001"-.002" is allowed.*

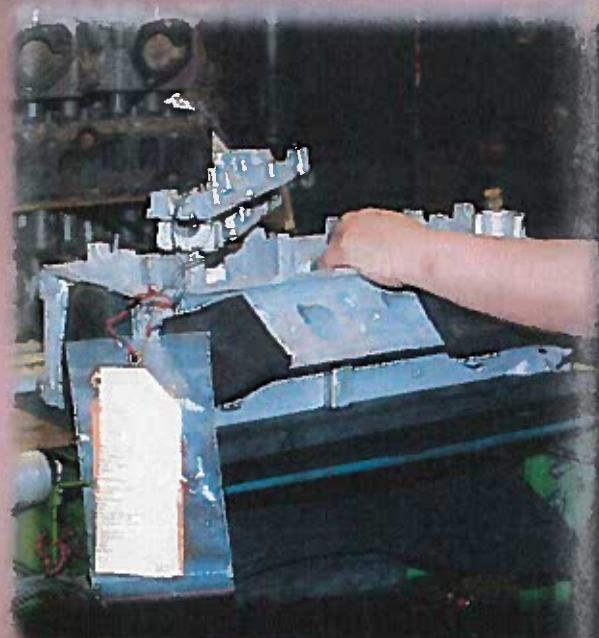
*Head being vacuum tested before going to stud and bolt repair station.*

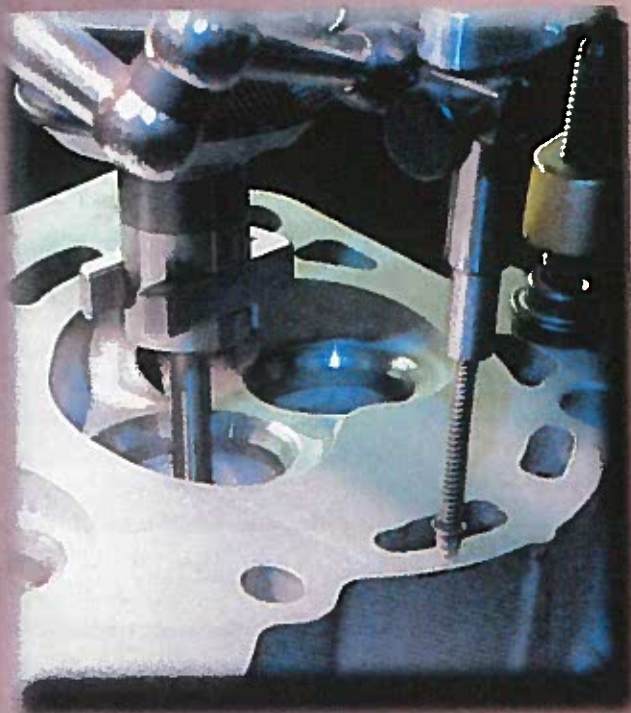
*Finishing the valve seats on a Toyota 3VZ head with a Serdi 5.0. VEGE only allows .020" off seats before replacing.*

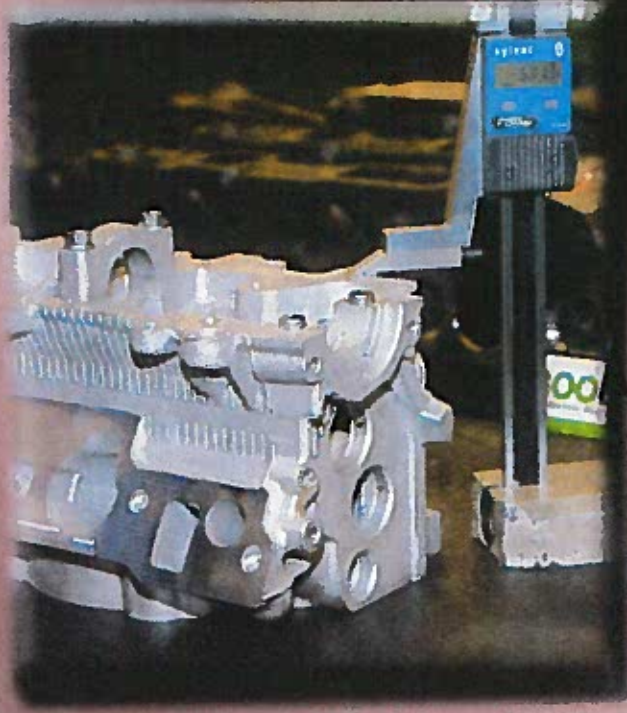
*Checking the thickness of the head. You need to try to maintain OE specs to maintain compression ratio. With ORD II coming, maintaining OE specs will be critical.*

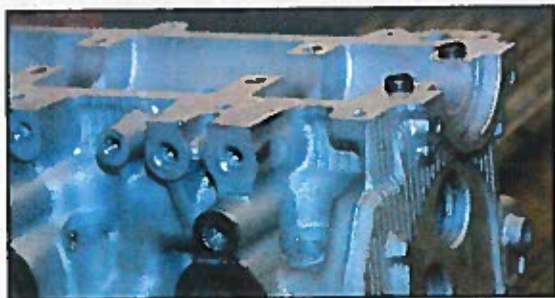
*On the Toyota 3VZ, dowel pins locate the cam bearing caps at #1 and #5.*

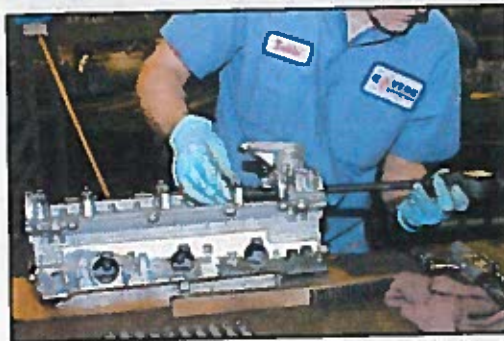
*Checking the cam housing size after cutting and reinstalling the caps to determine if there is enough material to hone or bore to finished size. Caps can be re-cut if there is not enough clearance.*

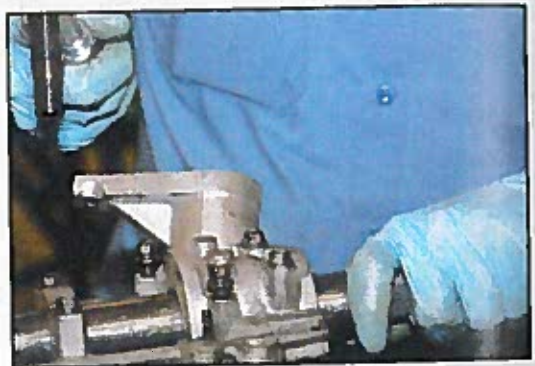
*Torquing the main bearing caps on cam housing with a size/straightening bar. One bank or side is torqued to align caps, bar is removed, then the rest of the caps are torqued. Cam bore can then be honed or bored as needed.*

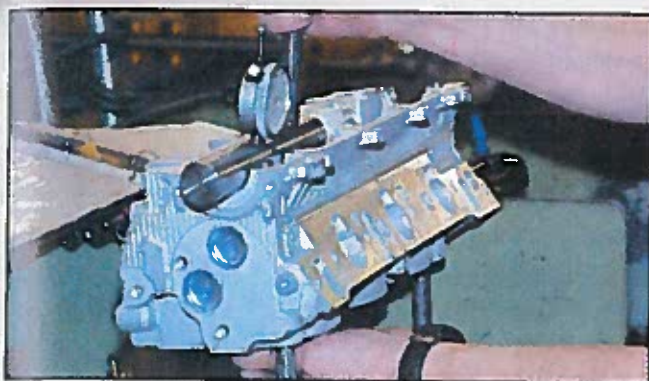
Checking installed valve height. With OBD II it is important to stay within OE specs.

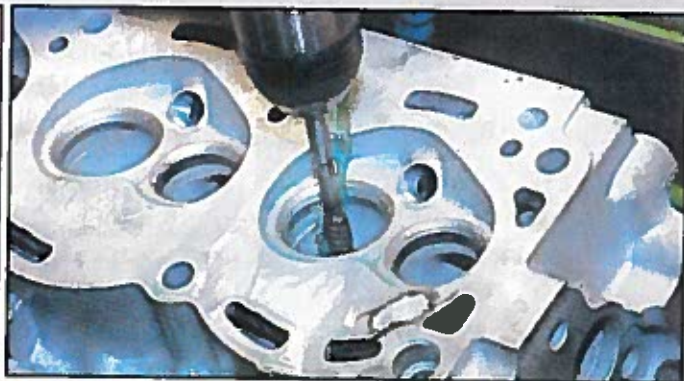
Diamond honing valve guide on a Toyota 3VZ head to remove nicks & burrs. Removes about .001"-.010".

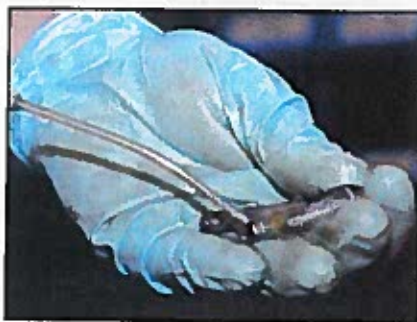
It is important to lubricate the threads as well as the head of all fasteners before torquing down.

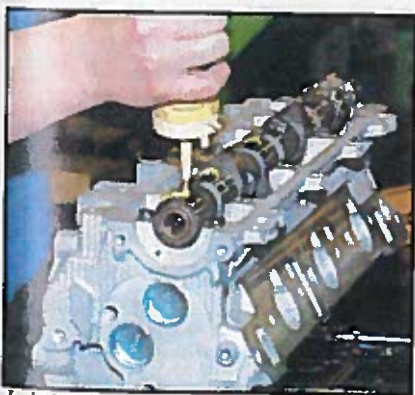
Lubrication is very important when reassembling an engine or head. When a newly remanufactured engine is first started it will run dry for several seconds and can cause damage if not properly lubricated during assembly.

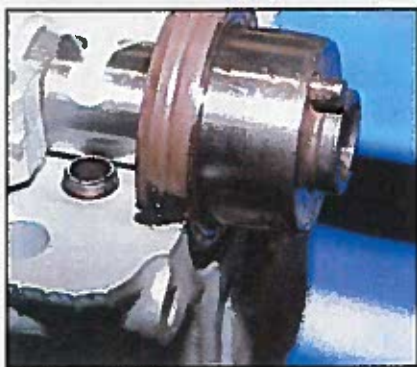
On the Toyota 3VZ heads, this point is a common cause of oil leaks. Application of a good sealant when reassembling will prevent future problems.

assembly fluid. Make sure the lifters move freely in their bores up and down as well as rotating. When installing the front and rear caps be sure to apply an RTV sealant to the corners. This is the last possible problem area you could have with these heads. They are well known for oil leaks and 99 percent of the time it is at the cap edges that they leak. Don't ruin a great rebuilding job by giving a customer a reason to complain of an oil leak.

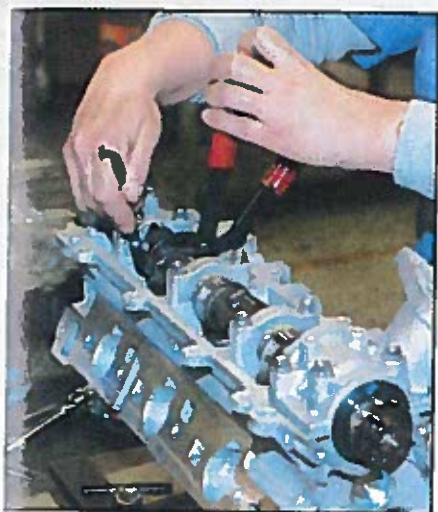
Checking valve lash and installing proper size shims for proper valve lash.

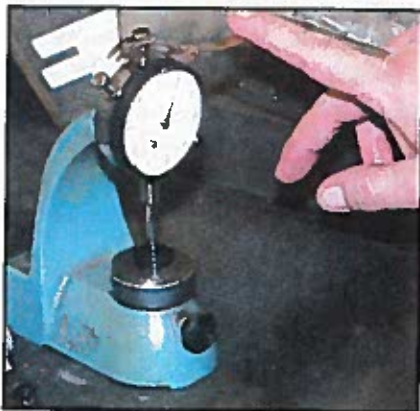
Checking a shim for proper size.

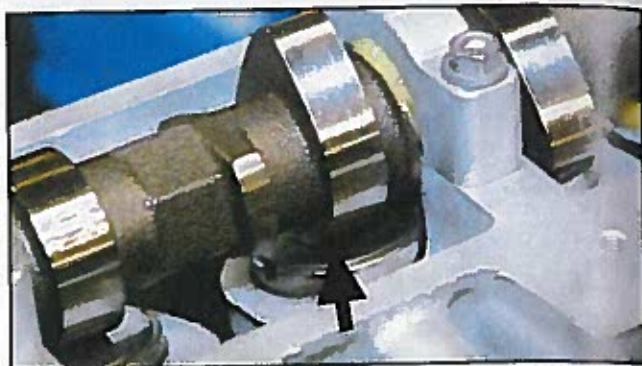
*Arrow shows shim that will give you the proper clearance. It is best to try to obtain a clearance that is in the middle of the OE range to allow for future adjustments.*
