TECH SOLUTIONS GUIDE

FORD MOTOR CO.

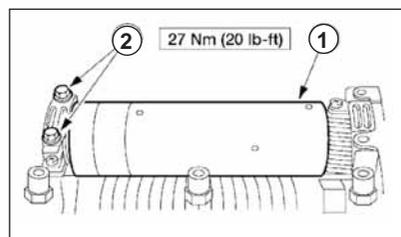
Figure 4 Balance shaft assembly torque specs (20 ft.lbs) for 4.0L Ford engine.

1) Install the balance shaft assembly

(Figure 4, page 2).

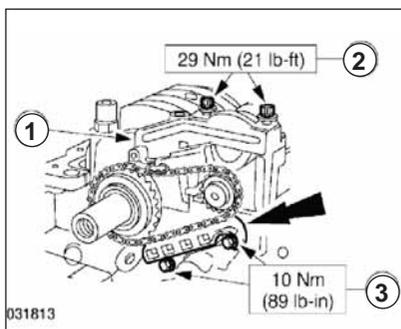
Figure 5 3.0L Ford engine balance shaft tensioner torque specifications.

7) Install the tensioner bolts (2) and torque to 21 ft.lbs. (29 Nm)

8) Position the balance shaft chain guide and install the two bolts (3) to 89 in.lbs. (10 Nm).

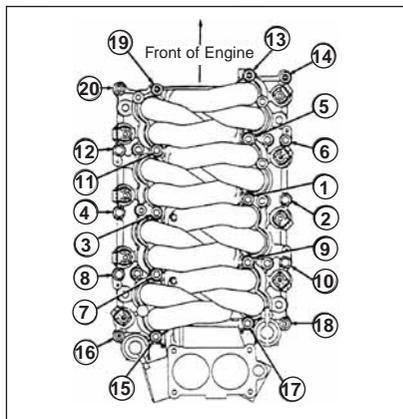
Figure 7 Lower intake manifold torque sequence for '93-'96 4.6L engines.

- 1) Clean and verify cylinder head and intake manifold surfaces are true and flat within .002" (.051 mm).
- 2) Install new intake manifold gaskets.
- 3) Following the sequence shown in **Figure 7** (above), tighten fasteners numbered 5, 7, 9, and 11 to 9-11 ft.lbs.
- 4) In sequence, tighten the remaining numbered fasteners to 13-16 ft.lbs.
- 5) In sequence, rotate all twenty fasteners an additional 85-95°.
- 6) Tighten the 4 intake manifold runner control (IMRC) bolts to 71-

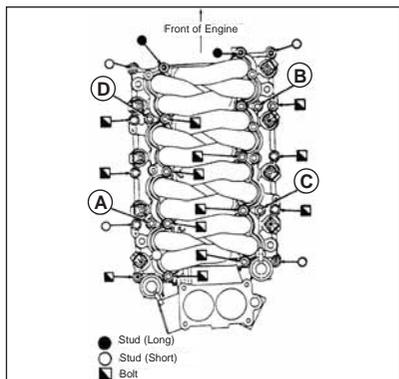
Figure 8 Torque sequence for 4.6L engine intake manifold runner control bolts.

89 in.lbs. in sequence (A, B, C, D) as shown in **Figure 8** (below).
