# IMPORT

## Crankcase Ventilation System Check For 1994-2007 BMW Engines

## Cylinder Head And Timing Belt Update On 2006-07 Hyundai 2.0L VIN D Engines

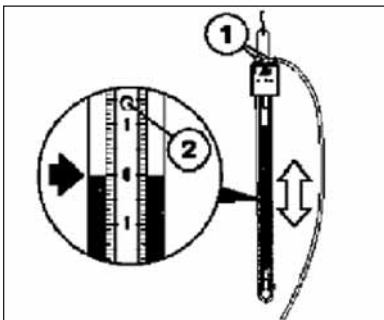
**Figure 2** BMW slack tube manometer tool.

To assist in troubleshooting the above complaints a special tool (p/n 99 00 0 001 410) has been developed to quickly check a pressure controlled crankcase ventilation system. Also refer to service information bulletin number 04 08 98 for further information regarding the slack tube manometer tool.

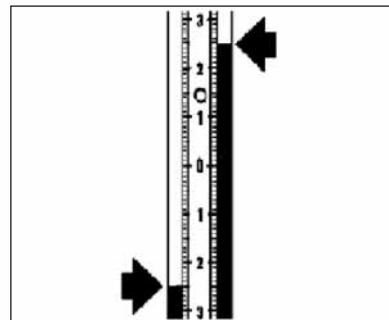
**Figure 3** The values on both sides must be added together to get the proper reading

5) The values on both sides of the slack tube must be added together to get the proper reading as seen in the illustration below in **Figure 3**, below.

6) Example:  $2.5 + 2.5 = 5.0$  inches of water (The readings may fluctuate 0.1 to 0.2 during the measurement which is normal and does not indicate a defect).

If a crankcase ventilation valve is defective (damaged diaphragm) the column of water will indicate an off the scale reading (all of the water on one side of the slack tube) which indicates a high crankcase vacuum.
