# REBUILDING THE FORD / NAVISTAR **7.3L** POWERSTROKE ENGINE

by Roy Berndt,  
Contributing Editor  
rberndt@engine-builder.com

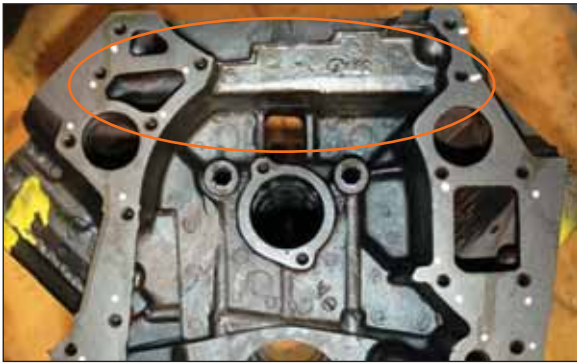
**Figure 2** The second design 6.9L casting has a wide gusset across the top front of the block. This casting is considered the only viable casting for rebuilding by most.

In 1984 the second series block (c/n 1807996C1) was introduced. With improved structural integrity, this is considered the block to use for all applications of 6.9L engines. To rapidly identify it, look at the same area in the front of the block (**Figure 2**) with the wide gusseting. The 6.9L was never turbocharged, therefore you will only require one long block part number for all 6.9L applications.

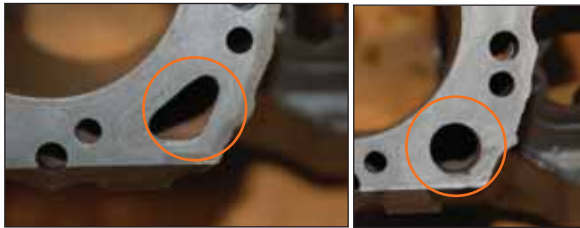
**Figure 3 and Figure 4** The coolant port on the corner of the cylinder head deck is triangular on the 6.9L engine (left). The coolant port on the corner of the cylinder head deck is circular on the 7.3L engine (right).

These walls were recorded as moving as much as .004". Since this block looks nearly identical to the 6.9L, the quick visual for identification are the coolant ports at the corners of the cylinder

deck. The 6.9L has triangular coolant ports (**Figure 3**), while the 7.3L coolant ports are round (**Figure 4**).

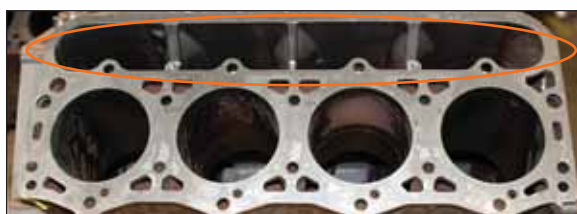
**Figure 6** First series 7.3L DIT blocks had a large opening at the upper valley area of the cylinder head deck.

There are, however, two different DI blocks. The first series design is readily identified by the lack of solid webbing in the valley up to the deck of the block (**Figure 6**). So if you're looking down on the deck toward the lifter bores it is one big opening.

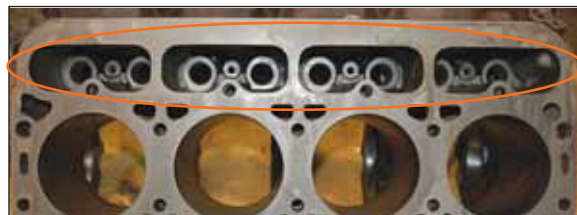
**Figure 7** The second series 7.3L DIT block casting has solid casting support areas between each cylinder bore as well as additional crank counterweight clearance in the lower block.

The second series block (c/n 1825849C2) is used from mid-1998-2004 with serial number 661,974 through 2,030,402. This block received some structural improvements such as additional crank counterweight clearance in the lower crankcase. The visual identifiers are the full casting separations between each cylinder in the lifter valley to the block deck (**Figure 7**).

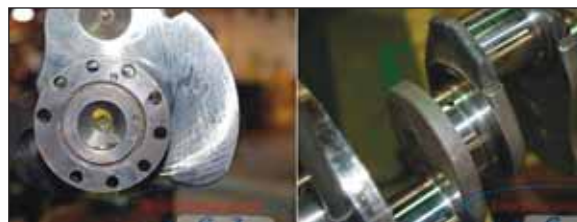
**Figure 8** All IDI and IDIT engines in both 6.9L and 7.3L sizes use the same crankshaft (c/n 1085420C1).

9-hole rear flange and the thrust flange located on No. 3 main journal (**Figure 8**).

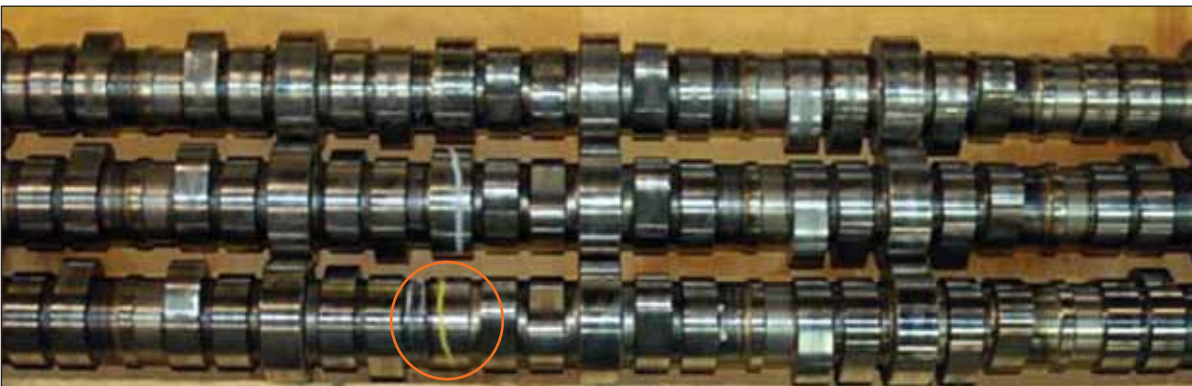
**Figure 11** Three camshafts were used in the 7.3L DIT engine application. The top two cams are the standard duty camshafts, while the bottom one is for heavy duty Ford and Internationals from s/n 661,0974-2,030,402. Note the absence of the pump lobe.

The stamping number on the back of the camshaft is 181062C1 and was used in both Ford and International applications from serial number 501 through 661,973. It is the upper most cam shown in **Figure 11**.

Ford Heavy Duty (F 650-750) and International went different ways here and continued to use the mechanical pump. Ford went to a frame mounted fuel conditioning module that does everything but put perfume in the cab. They went to an electric pressure pump; it is the bottom camshaft shown in **Figure 11**.

The middle camshaft in **Figure 11** is the cam used for Ford F650-750 applications and International trucks. This camshaft continued to maintain the mechanical rail pressure pump and carries the stamping number of 1826779C1.

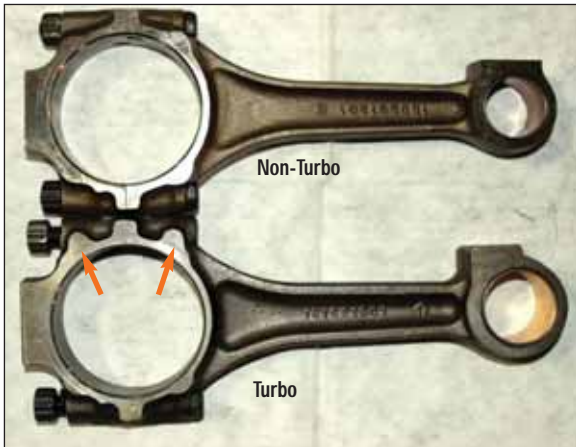
**Figure 12** The rod on top was used for all 6.9L and 7.3L non-turbo IDI applications from 1983-1994. The rod on the bottom was used in all turbo IDIT 7.3L engines from 1993-1994. Note the two boss areas for visual identification. The turbo also has a larger piston pin.

The same connecting rod (c/n 1816619C1) was used for all the 6.9L and 7.3L IDI non-turbo apps (**Figure 12**).

The 7.3L IDIT turbo connecting rod (c/n 1805615C1) has two bosses on the side of the rod and has a larger piston pin than the non-turbo (**Figures 12** and **13**).

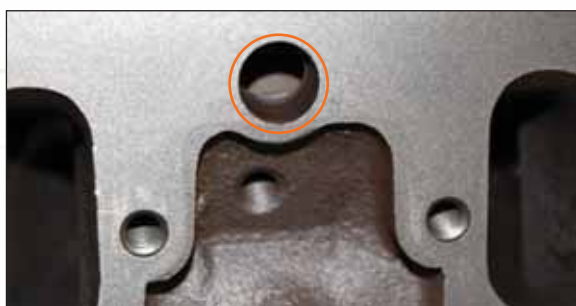
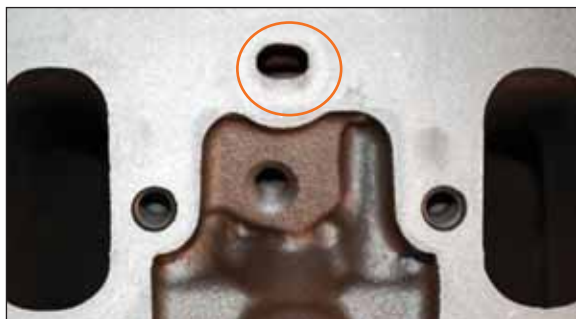
**Figure 16** 7.3L IDI and IDIT cylinder head castings may have two different shaped coolant ports. One is circular and uses a soft plug (top) and one is oblong without a plug (bottom). Both get covered by the gasket and both have c/n 1809030C3. They are fully interchangeable.

All 7.3L heads have head bolt holes for 1/2” head bolts and carry casting number 1809030C3. This casting comes in two flavors: one that has soft plugs on the intake side of the head and one that just has a port.

Both get covered by the gasket so it really does not make any difference which is used. Yet if a technician with a sharp eye sees it you might

want to have the explanation (**Figure 16**).

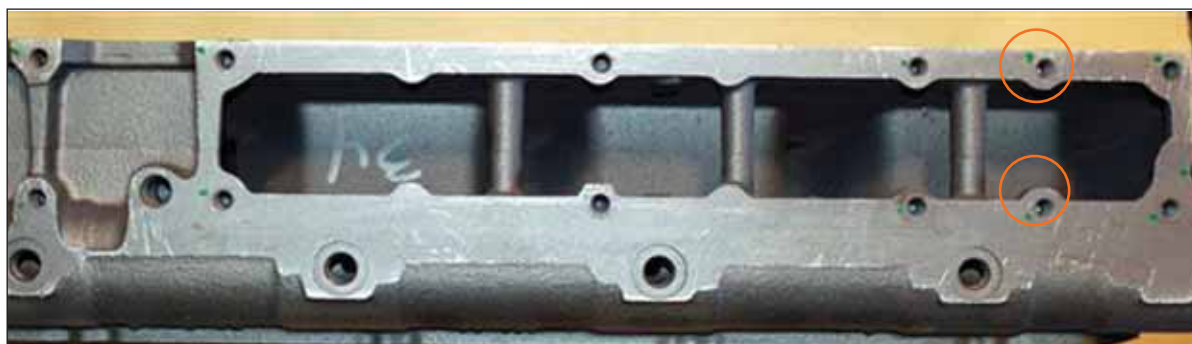
**Figure 17** This is the 10-bolt intake manifold cylinder head from the 7.3L (s/n 896,813 to end). Earlier 8-bolt cylinder heads did not have the two bolt bosses circled above.

This was the first series direct injection cylinder head (c/n 1821727C92). The identifier to this cylinder head is the 8 bolts (**Figure 17**) for the intake manifold. Use this head from serial number 501 through 375,548.

This is the second series direct injection head (c/n 11825113C1) and is easily identified by the 10 bolts (**Figure 17**) for the intake manifold. It was used from serial number 375,549 through 2,030,402. A 10 bolt cylinder head may be converted into an eight bolt by filling the two bolt holes circled in **Figure 17**. The heads are identical other than the bolts.

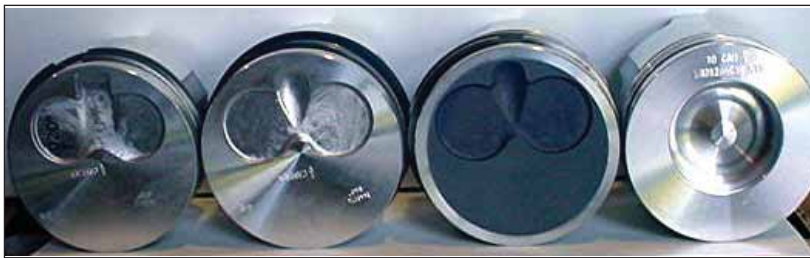
**Figure 18** At right (reading left to right) a comparison of the four different pistons used from the start of production to the end of production. From left: 6.9L, IDI non-turbo; 7.3L IDI non-turbo; 7.3L IDIT; and 7.3 DIT turbo.

There were four distinctly different pistons used for the various iterations of the 6.9L/7.3L engine. Each is unique and all are easily identifiable by their appearance. See **Figure 18** for the identification of each.

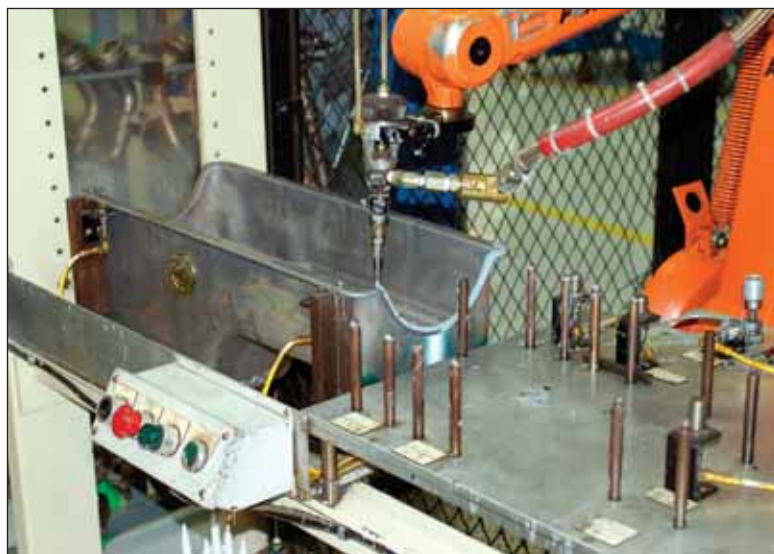
**Figure 22** When it needs to be sealed right every time, a robot is used to apply the exact amount of sealer.
