REBUILDING THE GM 6500 OPTIMIZER

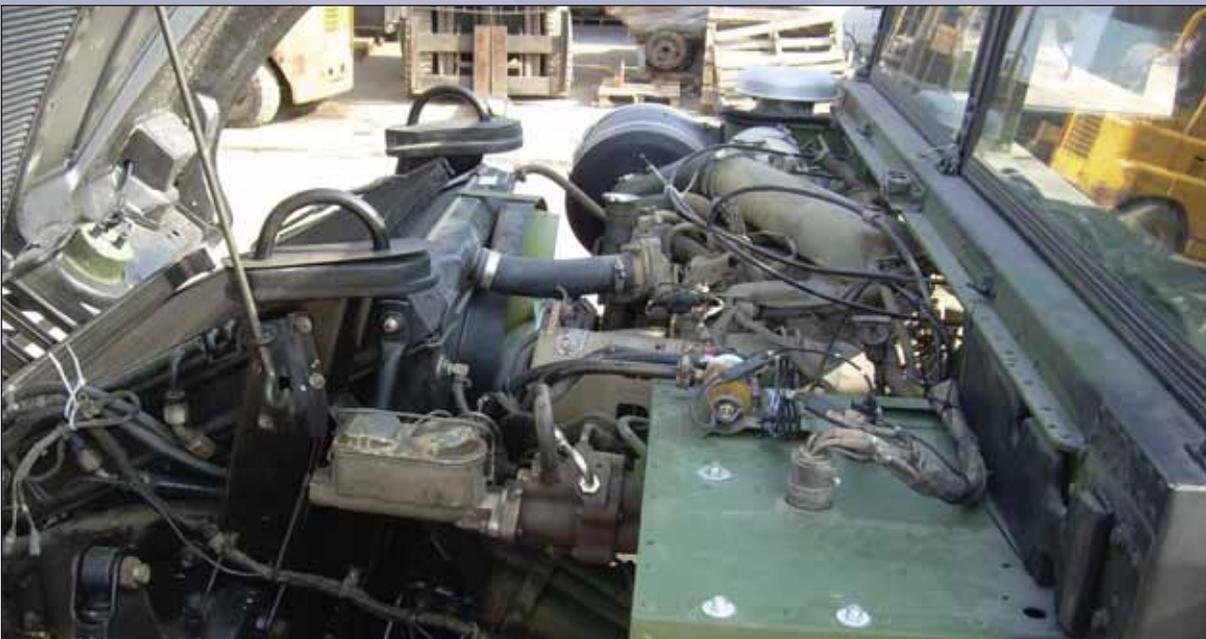
Underneath the hood of this Hummer beats a 6.5L GM diesel. Dependability in the field is critical, and several updates to the original engine have been made to ensure reliability.

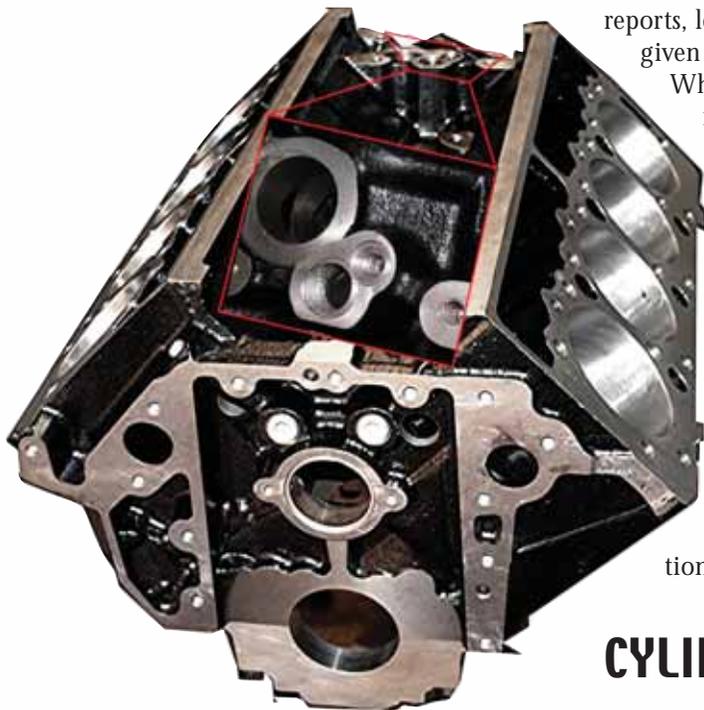
This universal block is available in the aftermarket for non-turbo, side-turbo or center mount-turbo block casting for 6.5L diesel or Optimizer 6500. There is very little, if any, core available – and what may be around probably isn't worth using.

That said, it sounds like an easy but somewhat costly solution, to just buy a new block, right? Sorry, the bad news is that you cannot buy a new block from GEP. Still, there is light at the end of that tunnel and it's not a train bearing down on you. There are a number of different aftermarket 6.5L diesel engine block, cylinder head, crankshaft and connecting rod manufacturers today. In fact, I found a manufacturer that provides a universal block for non-turbo, side turbo, and center turbo applications (see photo on page 24). We'll talk more of these potentials later in this article.

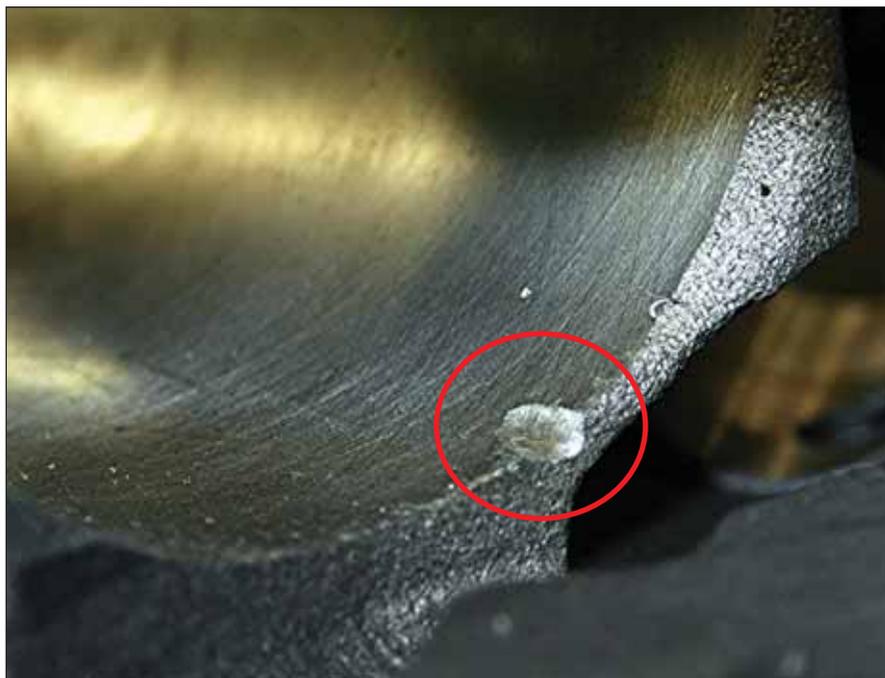
While machining for piston oiler holes in the main bearing saddles, tooling would occasionally contact the bottom of the cylinder bores, causing stress risers that have led to cracking.

oilers. Apparently the tooling would at times clip the bottom of the cylinder (see photo page 24) and, of course, would create a stress riser in the bottom of the bore. Occasionally, that would begin a vertical crack in the cylinder wall, most commonly in blocks that had a slight casting shift during their casting process. These were blocks that ended up with a thinner wall thickness, coincidentally, right in that area where the tooling clipped the cylinder.

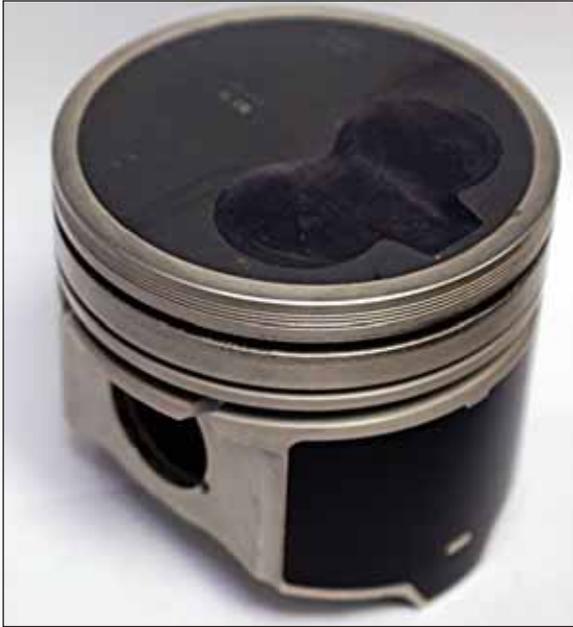
Mahle offers a coated piston to avoid any type of potential scuffing, particularly in the Nos. 7 and 8 cylinders, and especially in marine applications.

of the engine. Especially with the center-mount turbo, the rear of the engine runs hot. In fact, the piston to wall clearance for the rear two cylinders is .0005" more than the other six in the OE specification. In the aftermarket some manufacturers even recommend additional .001" clearance. Mahle has come out with a coated piston for this application (see photo above), which greatly reduces the possibility of scuffing even in the worst of situations and can be particularly beneficial in the marine application.

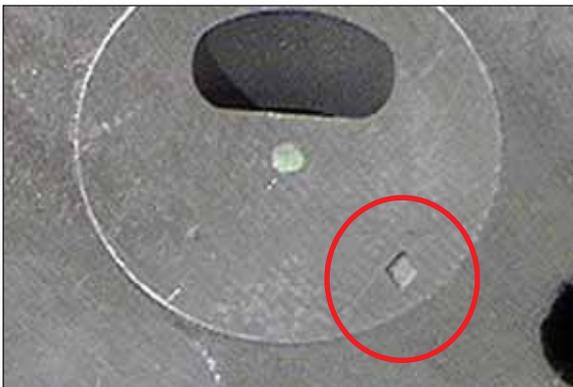
Diamond shape marking to identify pre-combustion chamber as the single universal pre-chamber for all applications.

Oddly enough, everyone in the PER sector that I have spoken with concerning remanufacturing this engine, has gone to the diamond pre-chamber (see photo on page 25) for all applications and has seen absolutely no detrimental effects, runnability problems or emissions issues.

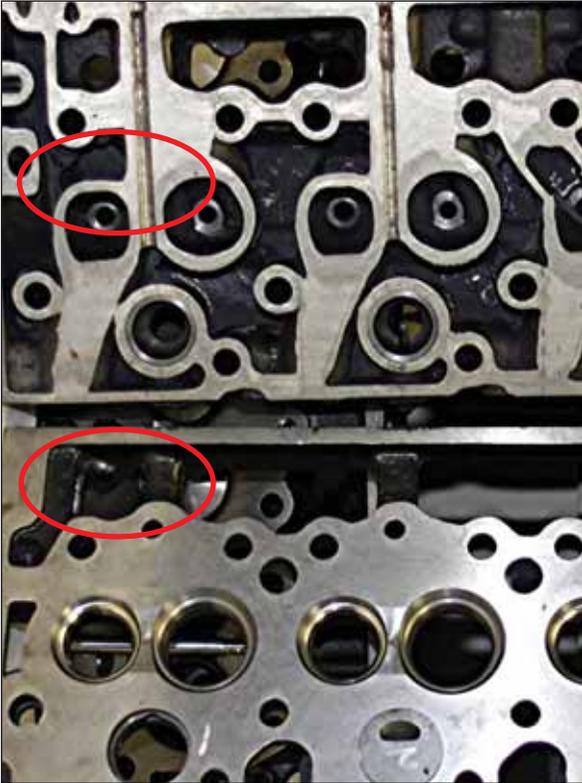
Here's a unique view of an aftermarket 6.5L cylinder head, cut apart to show improved areas of strength in the seat areas. This strength helps eliminate cracking between seat bosses and avoids guide repair through drilled coolant port. These heads already have hardened valve seats installed originally.

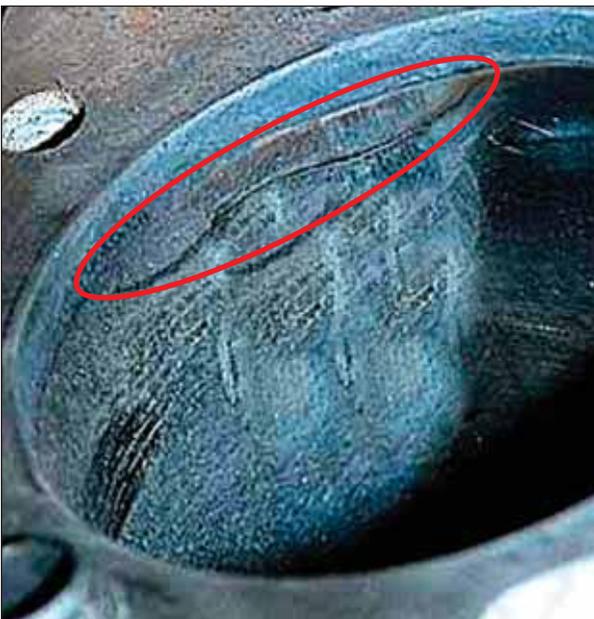
Example of circumference cracking, which is typical in No. 8 cylinder of 6.5L block castings prior to 1999. It was for this reason that the block deck bulkhead thickness was increased.

One improvement made has been to the block fire deck – it's been made thicker and more robust. The 1994 through 1998 turbocharged engine blocks were prone to circumference cracking, particularly in the Number 8 cylinder (see photo page 26 and GM Service Information Bulletin 98-02-05 dated 09/98).

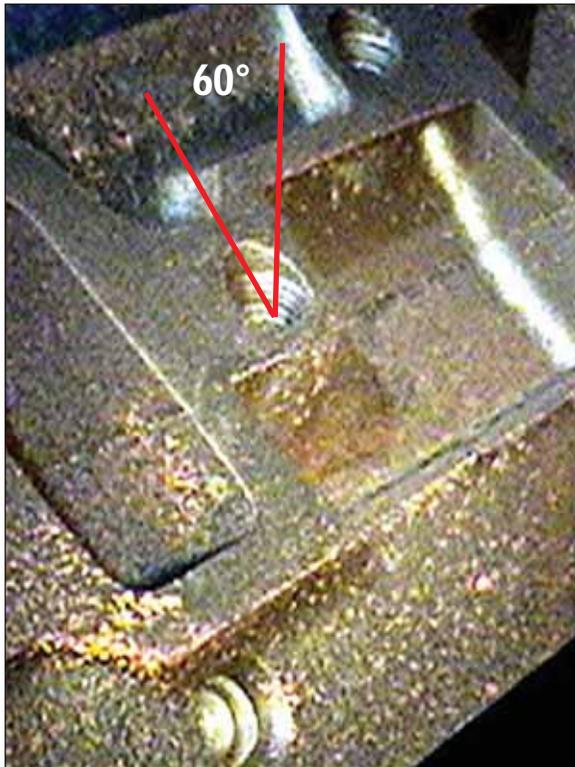
Here are intake manifold bolt holes at 60 degrees for intake manifold of center-mount turbo engine applications.

Other than the pre-combustion chambers the heads for the various engine configurations are basically the same except for the angle of the intake manifold bolts. The naturally aspirated or side-mount turbo applications have bolts that are at 90 degrees to the intake manifold surface. Intake bolts that are at 60 degrees (**see photo left**) to the intake manifold mounting face are found on the center-mount turbo manifold.

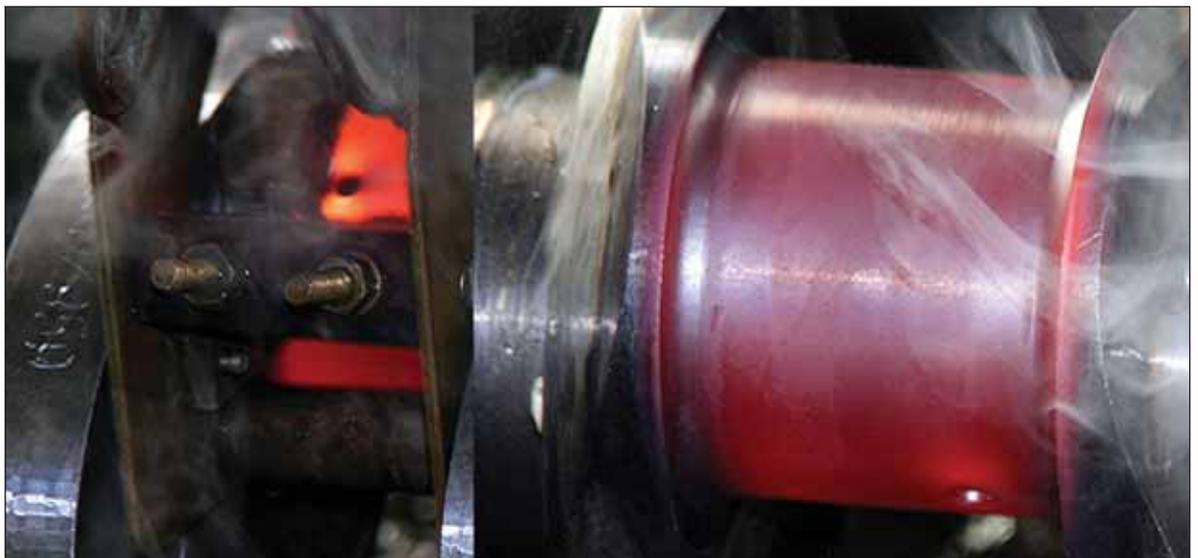
This is a close up view of the crankshaft induction hardening process. On the left is the activation tooling; on the right you can see the resulting heat in a localized journal area.

There is not a lot to talk about here. The crankshaft is induction hardened (see photo page 26) cast iron with rolled fillets and a one-piece seal rear flange. The flywheel bolts require sealant or they will leak. If torqued over 65 ft.lbs., as described by the OE spec, a rear seal leak will occur due to distortion of the rear seal area.
